Subject		Market
<b>Transfer Case Input Shaft Leak</b>		USA
Service Category	Section	
Drivetrain	Transfer/4wd/Awd	
Applicability		
2014-2016MY GX460

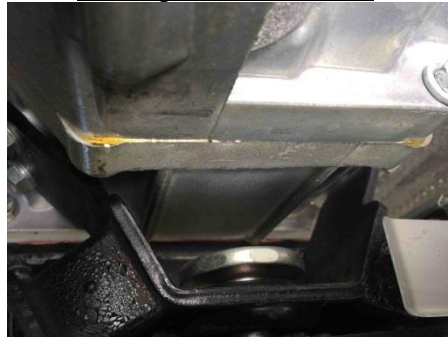
Mating surface seam

Certain vehicles may exhibit a leak from the input shaft seal on the transfer case assembly. This leak is typically first identified by gear oil colored fluid collecting at the bottom of the seam between the transmission output and transfer case input mating surfaces. See example photos below:

- Please do not disassemble. Take a picture of the condition and serial number of transmission, then create a TAS case and contact Technical Assistance (TAS) to submit details on any vehicle identified matching the condition described in this document prior to repair.
- If you are attempting to contact TAS on a weekend or TMS holiday, continue with diagnosis and submit the requested information on the next available work day. Retain all replaced parts and technician notes for possible review with TMS TAS Product Engineer.
