# Abnormal ("Squeak") Noise From Rear Suspension Over Uneven Road

## Applicability

| YEAR(S) | MODEL(S) | ADDITIONAL INFORMATION |
|---|---|---|
| 2014 | Highlander, Highlander HV | |

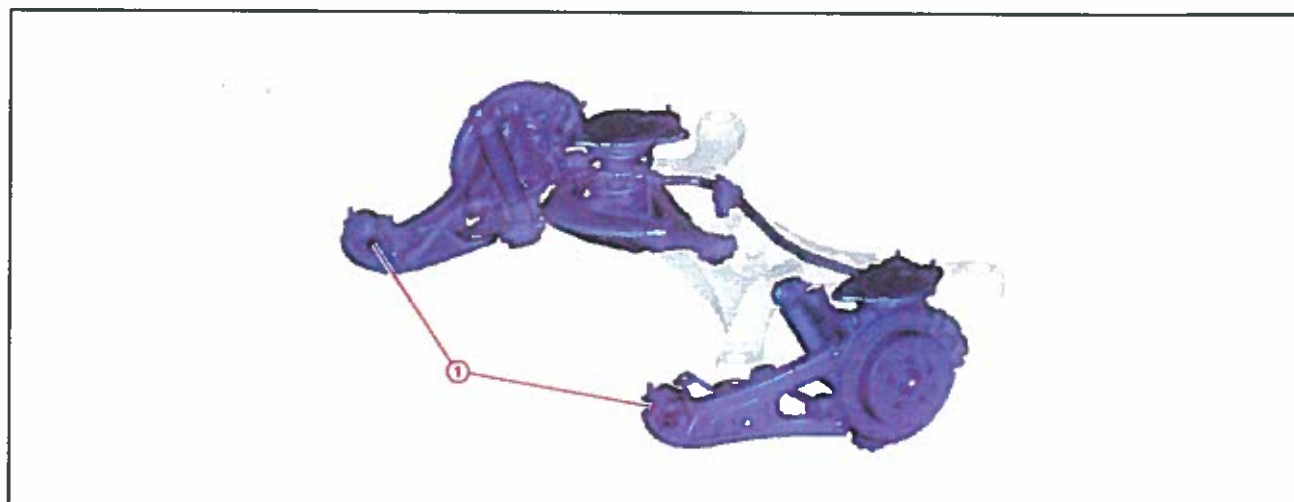
**Figure 1.**

Some 2014 model year Highlander and Highlander HV vehicles may exhibit an abnormal noise, like a "squeak/squawk/groan" type noise, from the rear suspension when traveling over uneven roads which may become more pronounced in colder ambient temperatures. The abnormal noise may be caused by the Rear Trailing Arm bushing. An updated Rear Trailing Arm Assembly is available. Follow the Repair Procedure in this bulletin to address this condition.

| <b>1</b> | Rear Trailing Arm Assembly Bushing |

3. Replace BOTH Rear Trailing Arm Assemblies even if only one side is emitting the "squeak/squawk/groan" type noise.

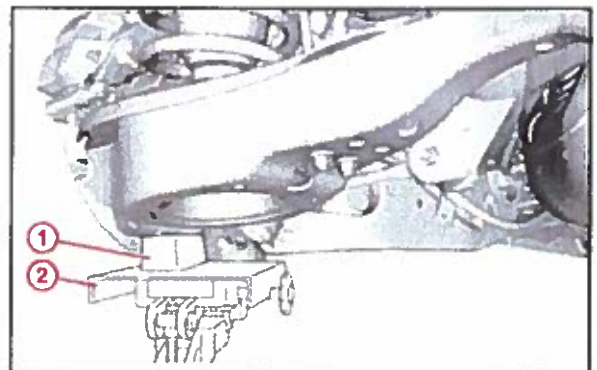
Figure 2.

| 1 | Wooden Block |
| 2 | Jack |

Support the rear No. 2 suspension arm assembly until reinstallation of the Rear Trailing Arm Assembly is complete.
