Front Axle Outboard Joint Grease Leak

Service Category Drivetrain

Section Drive Shaft/Propeller Shaft

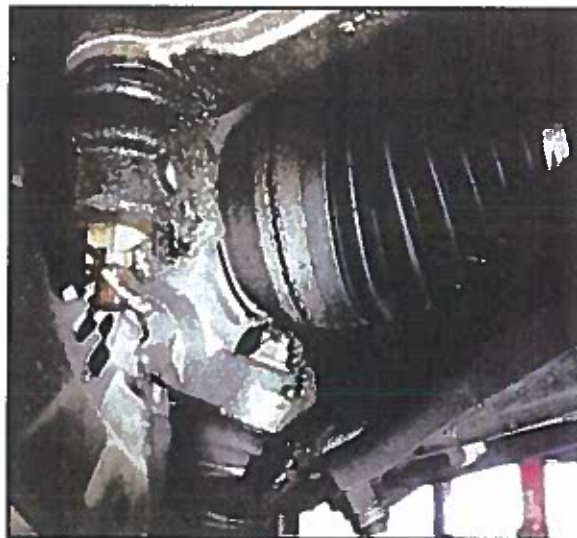
Figure 1.

Some 2015 – 2016 model year Sienna vehicles may exhibit a grease leak where grease is coming through the boot clamp area on the big end of the outboard front axle shaft joint. Follow the Repair Procedure in this bulletin to address the condition.

3. Replace the affected axle shaft.

Do NOT replace just the boot kit for this concern, full axle shaft replacement is necessary.
