# Abnormal Noise from Low Pressure Fuel Pump

**Service Category** Engine/Hybrid System

**Section** Fuel System

YEAR(S)	MODEL(S)	ADDITIONAL INFORMATION
2016	GS F	
2015 - 2016	RC F

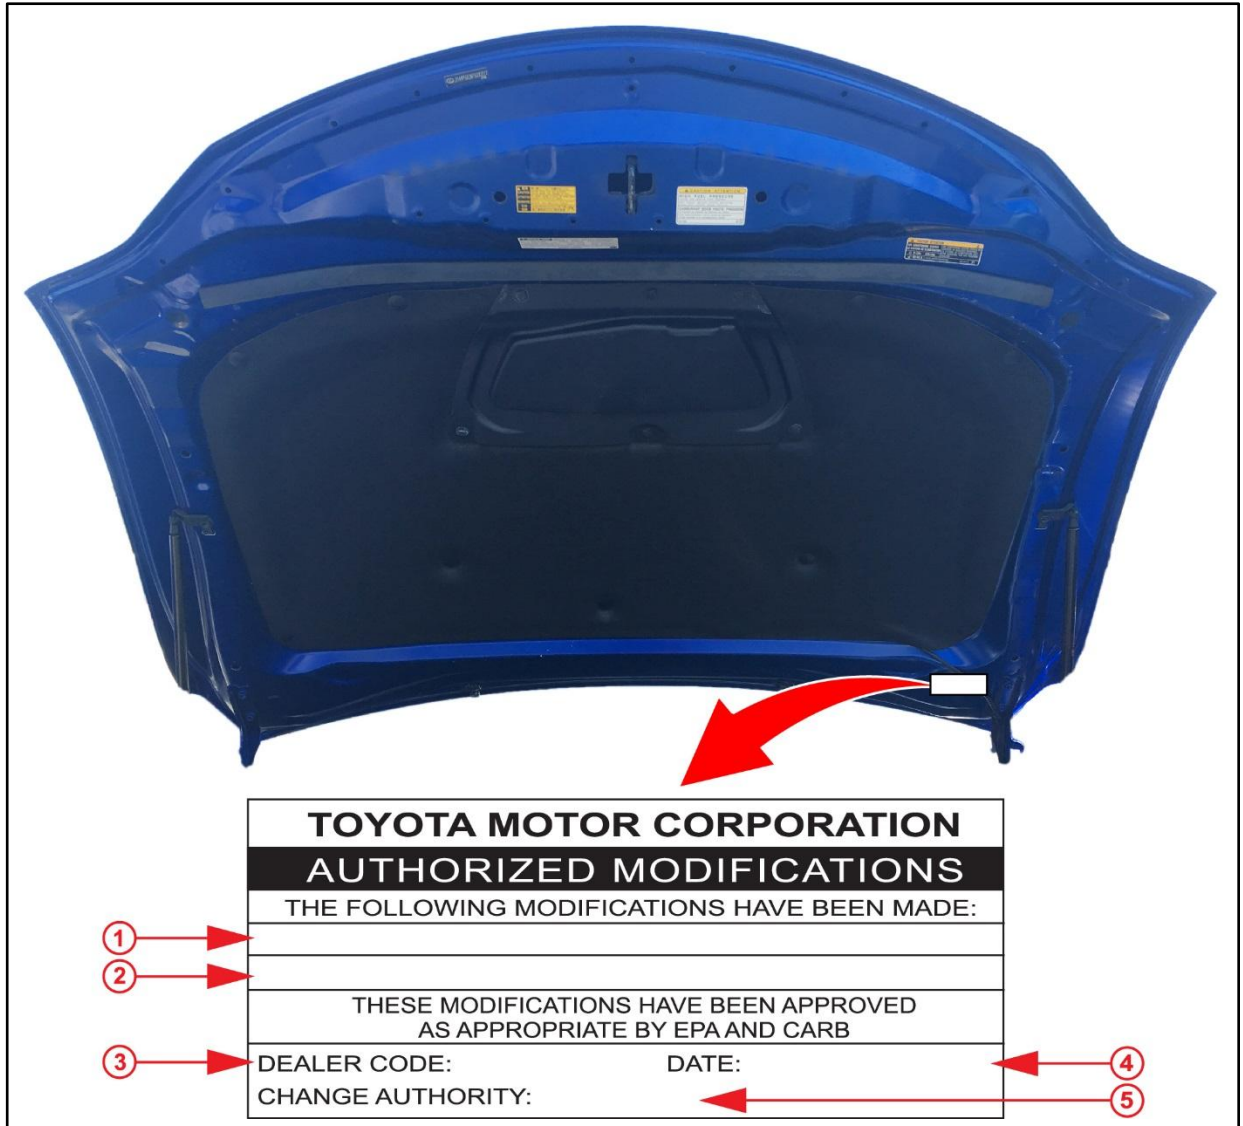
**Figure 1. Location of Authorized Modification Label for 2015 – 2016 RC F**

1	Replacement ECM (PCM) Part Number (i.e., 89661-24893)
2	New Calibration ID (i.e., 32428300)
3	Dealer Code

4	Date Completed
5	This SB Number

- Check for the Authorized Modifications Label affixed to the vehicle in the location shown below. Confirm if the ECM (PCM) calibration has been updated. If the calibration ID listed is NOT the latest ECM (PCM) calibration – go to step 4. If the calibration ID listed IS the latest ECM (PCM) calibration, disregard this Service Bulletin and continue diagnosis per the Repair Manual.

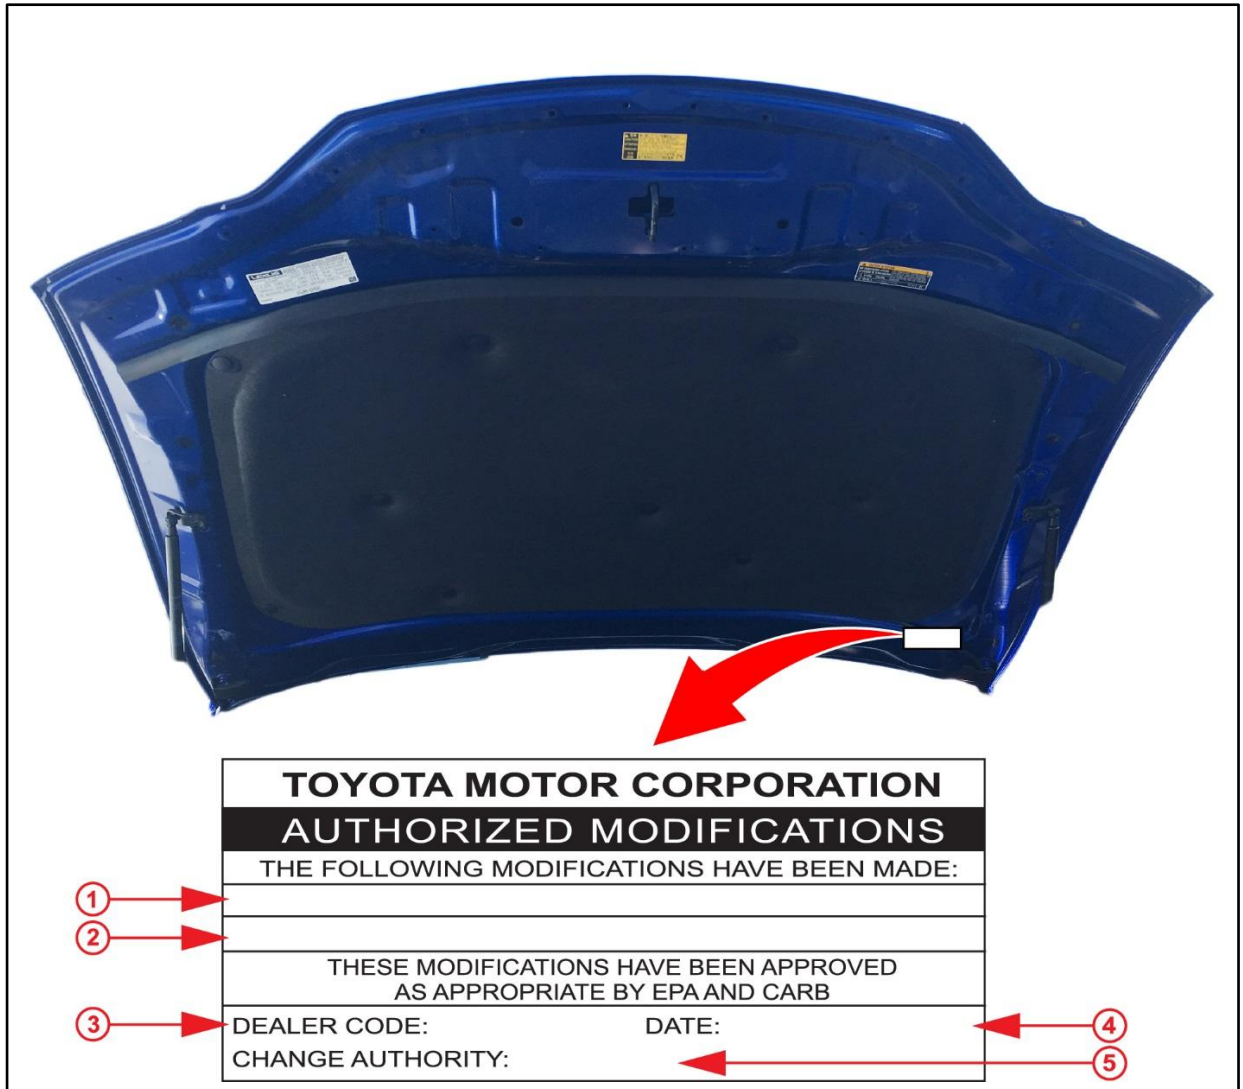
Figure 2. Location of Authorized Modification Label for 2016 GS F

1	Replacement ECM (PCM) Part Number (i.e., 89661-3AC01)
2	New Calibration ID (i.e., 33075100)
3	Dealer Code

4	Date Completed
5	This SB Number
