# MIL "ON" DTC P2610

YEAR(S)	MODEL(S)	ADDITIONAL INFORMATION
2014 - 2015	IS250

Some 2014 – 2015 model year IS 250 vehicles may exhibit a MIL “ON” condition with Diagnostic Trouble Code (DTC) P2610 present, indicating an ECM/PCM engine OFF Timer Performance condition. The Engine Control Module (ECM) logic has been modified to reduce the possibility of this condition. Please follow the Repair Procedure below to address this condition.

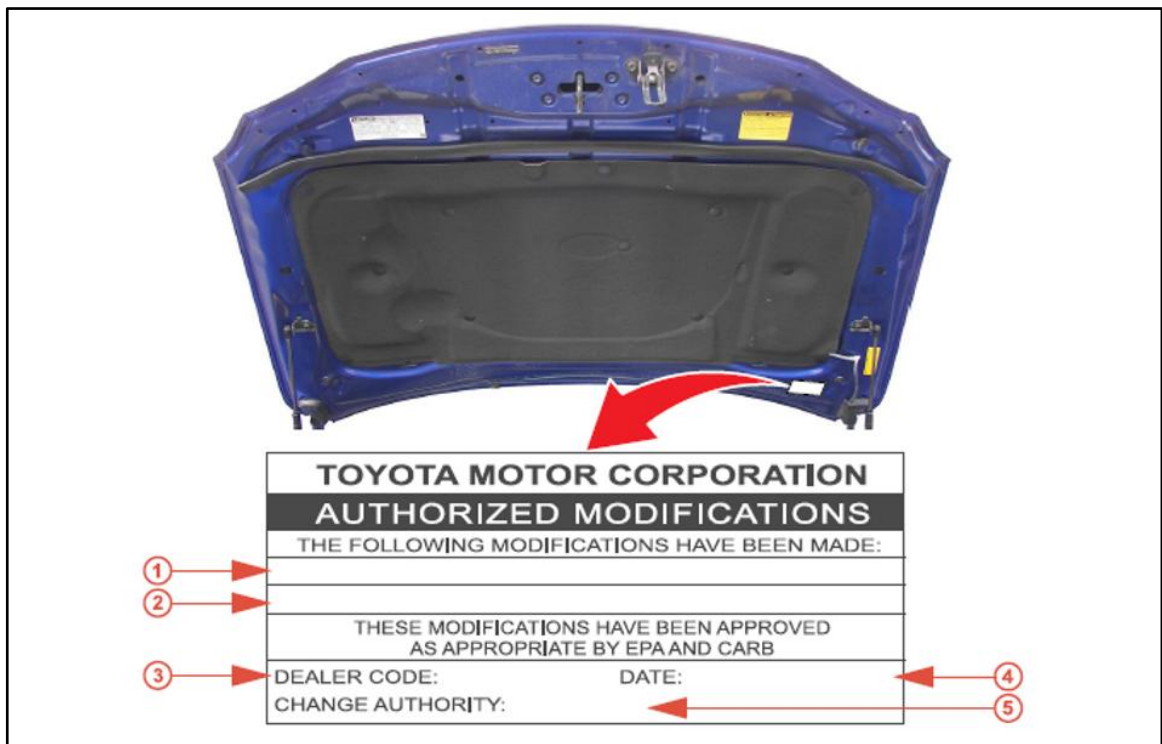
**Figure 1: Location of Authorized Modifications Label on 2014-2015 IS 250**

- Check for the Authorized Modifications Label affixed to the vehicles in the location shown below. Confirm if the ECM (PCM) calibration has been updated.

4. Install the Authorized Modifications Label.
  - A. Using a permanent marker, enter the following information on the label:
    - ECM part number [Refer to the **Parts Information** section for the **NEW PART NUMBER**]
    - Calibration ID(s) [Refer to the **Calibration Information** section for the **NEW CALIBRATION ID**]
    - Dealer Code
    - Repair Date
    - Change Authority [**This bulletin number**]
5. Affix the Authorized Modifications Label to the vehicle at the location shown in Figure 1. The Authorized Modifications Label is available through the MDC, P/N 00451-00001-LBL.
6. Test drive the vehicle to confirm proper vehicle operation.
