# Service Bulletin

Bulletin No.: 16-NA-144

**Subject:** Windshield Wipers Inoperative

Brand:	Model:	Model Year:		VIN:		Engine:	Transmission:
		from	to	from	to		
Chevrolet	Equinox	2010	2016			All	All
GMC	Terrain	2010	2016			All	All

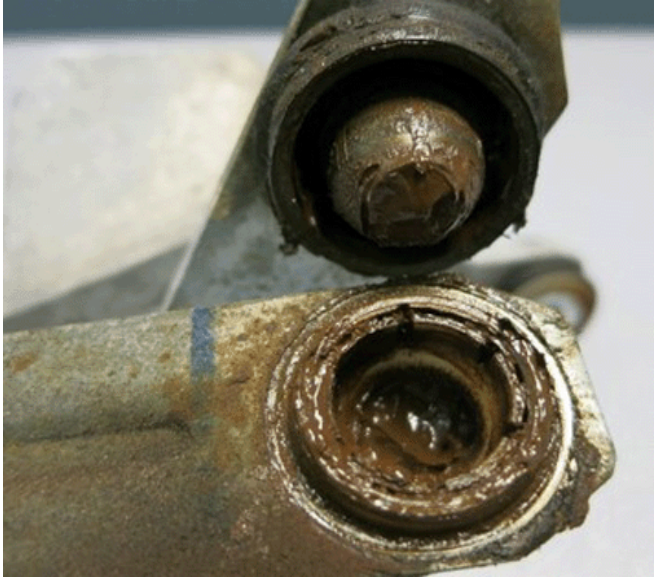
<p style="text-align: right;">4508271</p> <p>This may be caused by the wiper transmission linkage separating due to corrosion at the ball socket joints.</p>

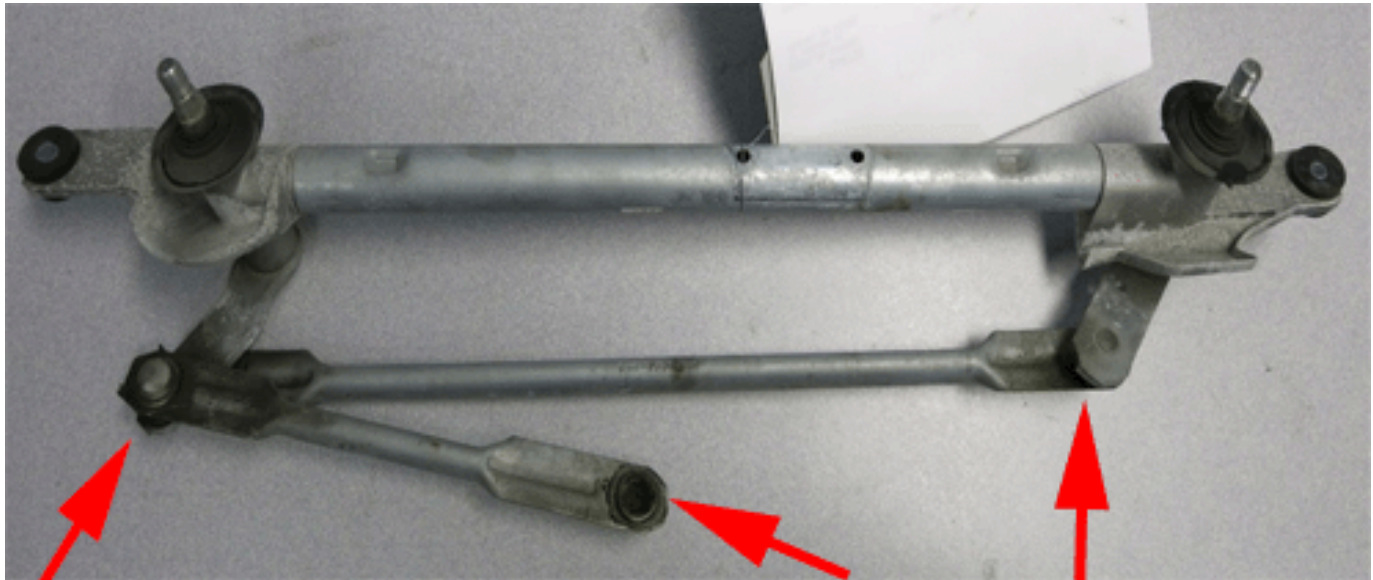
4508274

2. Once the screen is removed, visually inspect the wiper transmission and wiper motor link sockets for corrosion or damage.
3. If the sockets show signs of corrosion or damage, replace the wiper transmission and wiper motor. Refer to *Windshield Wiper Transmission Replacement* and *Windshield Wiper Motor Replacement* in SI.
