Service Bulletin

Bulletin No.: 16-NA-115

Subject: Radio Inoperative with No Communication and DTC U0184, No XM on Start-Up when

Manually Tuned and/or Using Voice Recognition, No Radio Wake-Up, Rear View Camera and OnStar Handsfree Calling Issues, Favorite Stations Stored Twice and/or

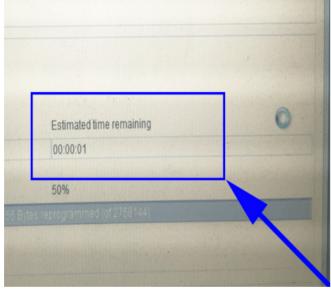
Important: During the SPS procedure, when the estimated time remaining reaches 00:00:01, it may take a few minutes to complete the reprogramming. Be sure to wait until the reprogramming is completed.

An updated software calibration as well as new hardware have been released to address this condition. Update the radio using the Service Programming System (SPS) with the latest calibrations available on TIS2WEB. Refer to the SPS procedures in SI.
