Technical Bulletin

01 16 04 April 8, 2016 2043736

MIL ON, DTC P05A3 and/or P05A0 Active Radiator Shutter Grille faults stored in ECM Fault Memory

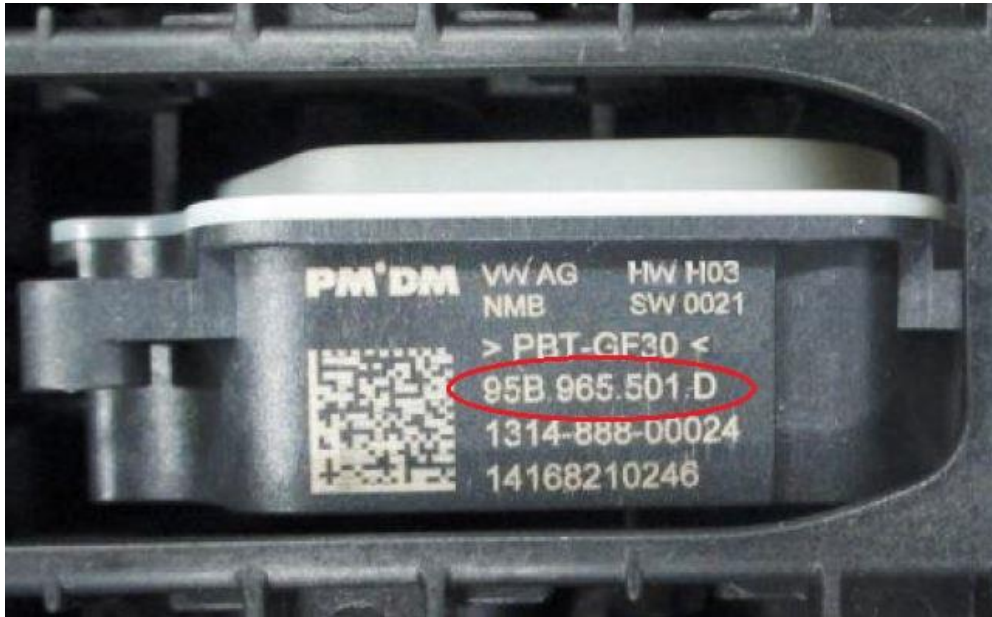
Figure 1

Inspect the Active Radiator Grille motor part number (located on the motor itself, see Figure 1) and perform one of the two following steps.

- If part number is less than 95B 965 501 H, similar to the picture below, the motor/grille will need to be replaced.
- If part number is 95B 965 501 H or higher, the motor/grille is OK and normal Guided Fault Finding diagnosis must be performed. This technical bulletin does not apply.

If the Active Radiator Grille needs to be replaced, follow the steps outlined in ELSA to replace the Active Radiator Grille.
