Service Bulletin

Bulletin No.: 16-NA-183

Subject: Transmission May Not Shift Out of Park, Shifter Knob Indicators May Not Illuminate, DIC Messages May Say to Service Transmission, Service Transmission Now, Unable to Shift Soon

Brand:	Model:	Model Year:		VIN:		Engine:	Transmission:
		from	to	from	to		
Buick	LaCrosse	2017	2017				
Cadillac	XT5

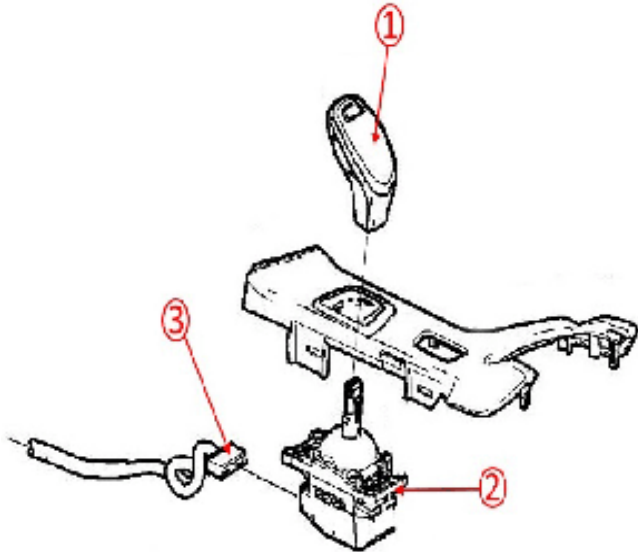
4528887

Involved Region or Country	North America and N.A. Export Regions
Condition	<p>Some customers may comment on one or more of the following conditions:</p> <ul style="list-style-type: none"> • Transmission may not shift out of park. • DIC messages say to Service Transmission and/or Service transmission now, Unable to Shift Soon. • The shift indicator knob doesn't illuminate. <p>The Technician may find one or more of the following DTCs set:</p> <ul style="list-style-type: none"> • P07B4 • P07BA • P07BB • P17A4 • P17A5 • P17A8 • P26C8 • U0077 • U156D
Cause	<p>This may be caused by the following conditions:</p> <ul style="list-style-type: none"> • Transmission Control Lever Knob assembly not fully seated onto the shifter. • Electrical connector not fully engaged into the Automatic Transmission Electronic Control.

1. While pressing downward on the shifter knob (1) firmly with both hands, validate any movement felt and the bottoming out of the knob to shifter (2).
 - If movement was confirmed while pressing downward on the shifter knob, an audible click may be heard.
 - Verify the shift knob lighting is illuminated and the shifter assembly moves freely.
2. Clear the codes set in the Chassis Control Module and test drive the vehicle.
 - If the codes did not return, no further repairs are needed.
 - If the codes return, validation of the wiring harness connector (3) for the transmission electronic control (2) needs to be done.

3. Remove the Transmission Electronic Control. Refer to *Transmission Electronic Control Replacement* in SI.
4. Press the electrical connector firmly into the Transmission Electronic Control.
5. Validate that the CPA is in the locked position on the connector.
6. Install the Transmission Electronic Control. **Tighten** the bolts to 9 N•m (80 lb in).
7. Verify the shift knob lighting is illuminated and the shifter assembly moves freely.
