# Service Bulletin

Bulletin No.: 16-NA-283

**Subject:** Instrument Panel (IP) Top Trim Pad to Navigation Screen Upper Trim Cover Misalignment

Brand:	Model:	Model Year:		VIN Breakpoint:		Engine:	Transmission:
		from	to	from	to		
Chevrolet	Impala (VIN 1)	2016	2016	SOP	GU160808	All	All

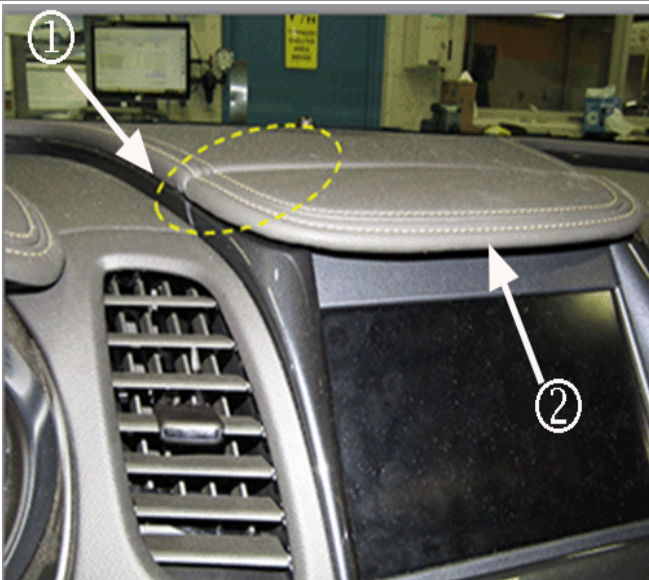
</div> <p>4579171</p> <p>Some customers may comment on a misalignment of the IP top trim pad (1) to the navigation screen upper trim cover (2). This causes the right side of the upper trim cover to appear higher than the left side, which is the most common customer concern.</p>

Add a self threading nut to the unprocessed heat stake on the IP top trim pad and drill a clearance hole into the IP carrier, following the Part Information and Service Procedure below.

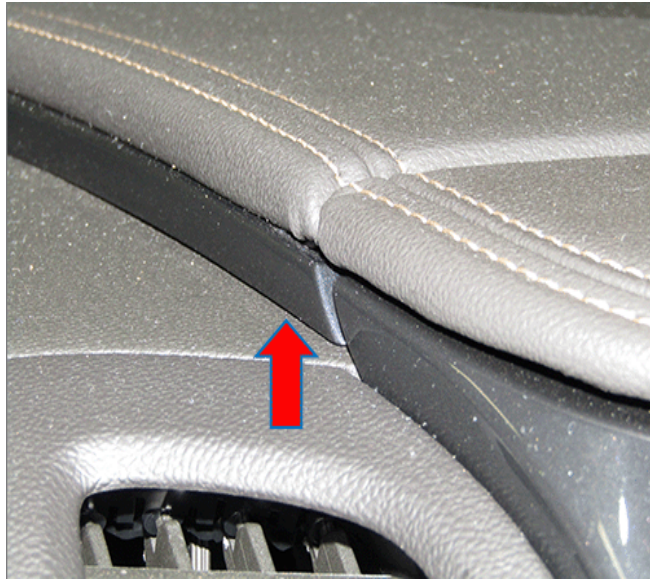
The cause of the condition may be a heat stake/sonic weld left unprocessed at the supplier. This standing heat stake results in the IP pushing upward on the IP carrier, causing a gap at the left side of the trim cover.

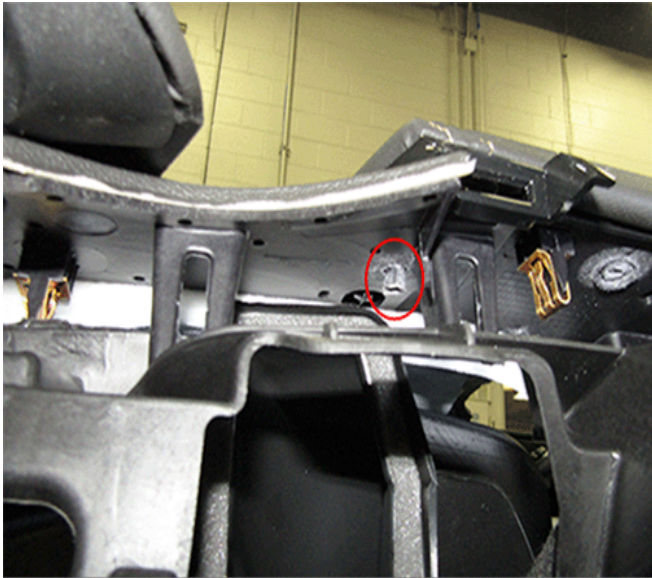
2. Locate the unprocessed heat stake (shown circled in the graphic above) on the driver side of the trim pad.

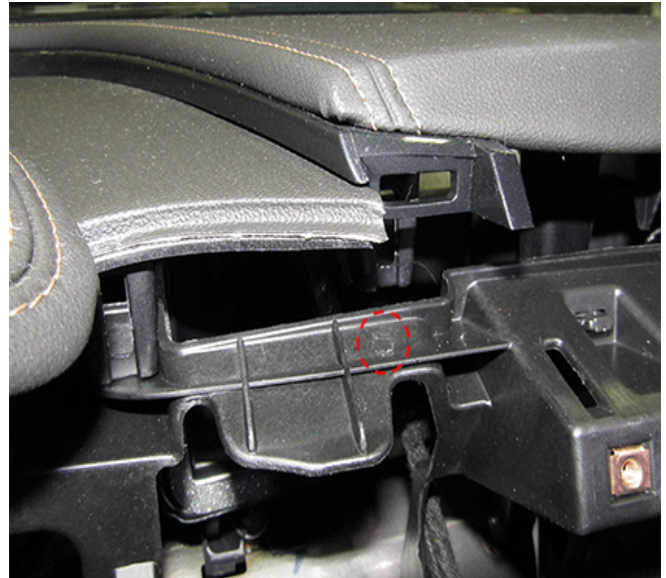
4. In-line with the heat stake location, inspect the black plastic IP carrier for a witness mark (shown circled in the graphic above) on the drivers side, where the heat stake has been contacting the carrier.
