# Service Bulletin

Bulletin No.: 16-NA-308

**Subject: Water Leak Around Rear Window, Water Found in Trunk, Possible Malfunction Indicator Lamp (MIL) Illuminated**

Brand:	Model:	Model Year:		Date Breakpoint:		Engine:	Transmission:
		from	to	from	to		
Chevrolet	Cruze (VIN B)	2016	2017	SOP 2016	September 6, 2016	ALL	ALL

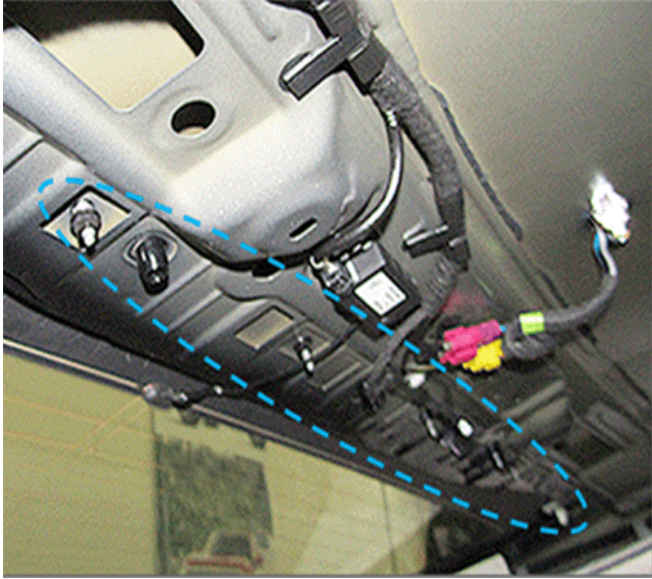
<p style="text-align: right; font-size: small;">4583911</p> <p>The cause of the condition may be loose or missing nuts retaining the Center High Mounted Stop Lamp (CHMSL), which may allow water to by-pass the CHMSL and flow into the trunk area.</p>

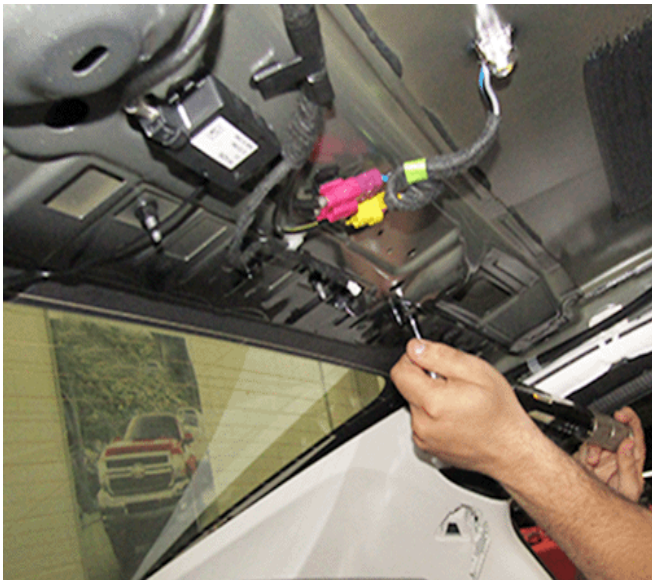
4583913

2. Lower the rear of the headliner enough to access the four nuts that retain the CHMSL. Refer to *High Mount Stop Lamp Replacement* in SI.

3. Install new nuts at any locations that may be missing, then verify proper torque specification at all four locations.
