# Service Bulletin

Bulletin No.: 16-NA-352

**Subject:** Information on Convertible Top Inoperative and Extend Cargo Shade to Operate Top Message Displayed in DIC, Though Shade Extended

Brand:	Model:	Model Year:		VIN:		Engine:	Transmission:
		from	to	from	to		
Buick	Cascada	2016	2017			All	All

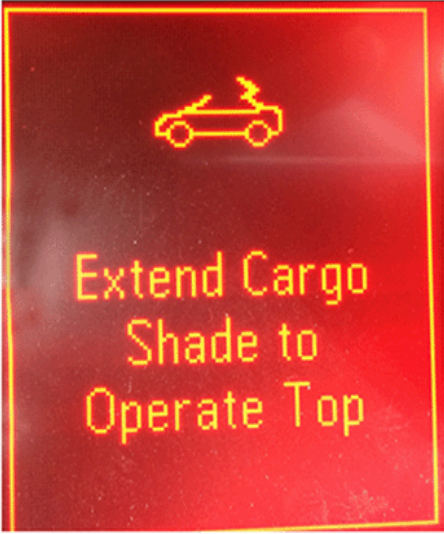
</div> <p style="text-align: right; font-size: small;">4593603</p> <p>Some customers may comment that the convertible top is inoperative and "Extend Cargo Shade to Operate Top" message is displayed in the DIC, though shade is extended.</p>

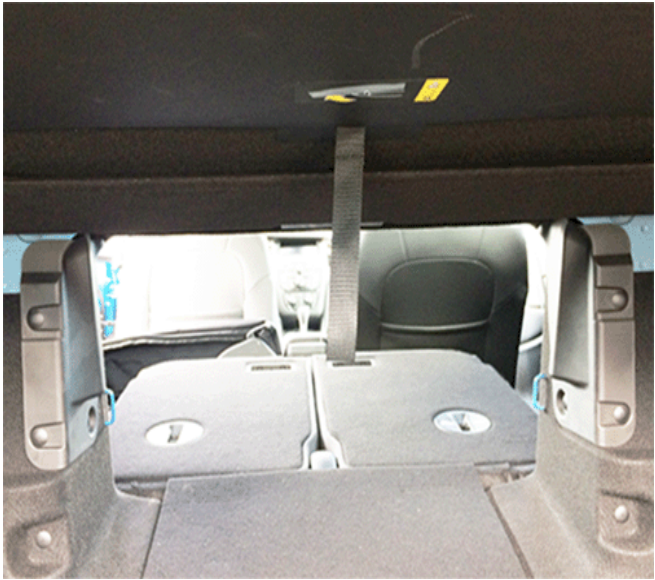
<p>4593605</p> <p>The cause of the condition may be that the pass-through flap on the rear cargo shade/partition may be improperly positioned. If this flap is folded upward into pass-through position (shown above in view from trunk), magnets on the flap will not contact the sensors, which allow for top operation.</p>
--------------	---

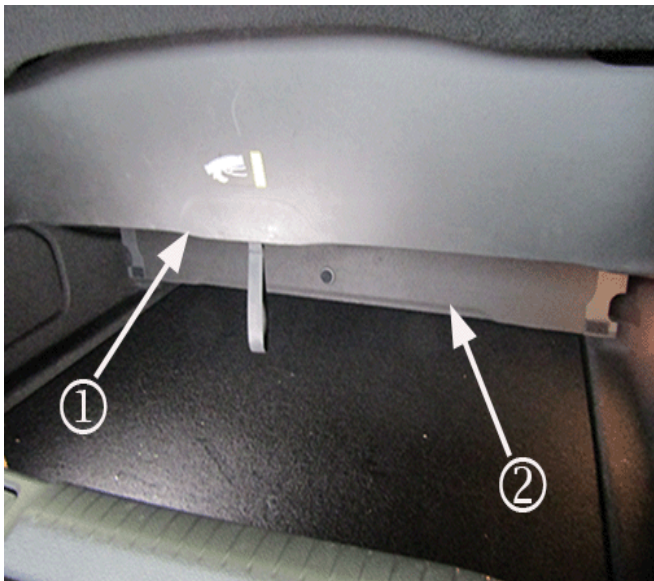
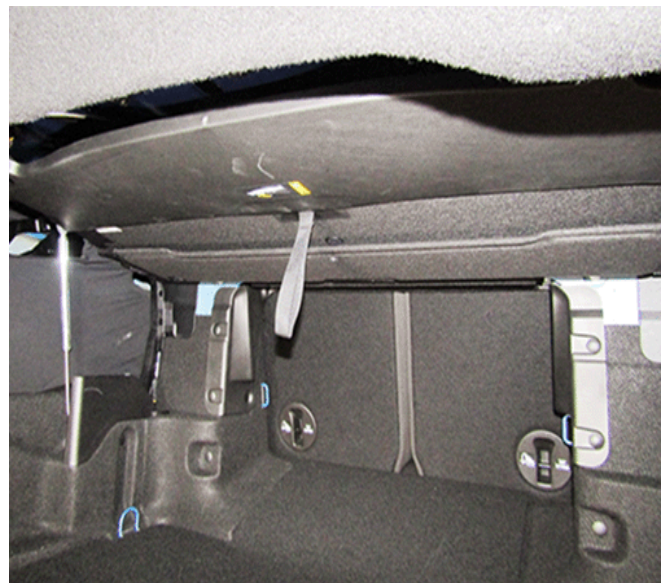
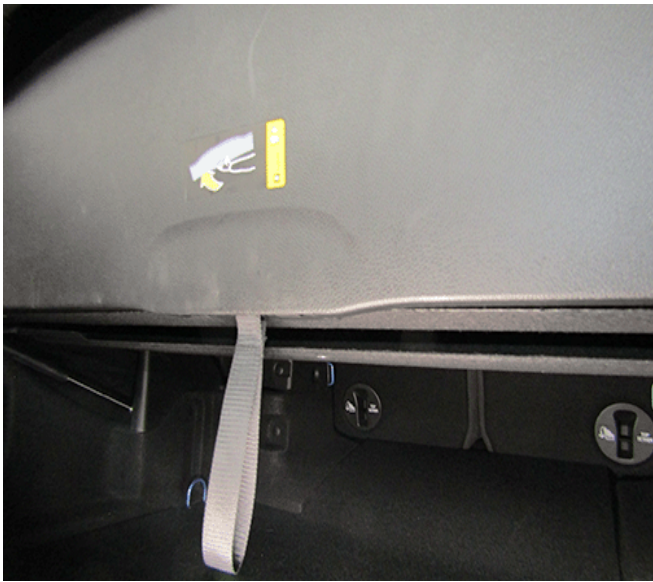
⇒ If the rear partition and the forward flap are in any of the positions shown in the three graphic examples shown above, **the top will not operate.**

1. Open the trunk and inspect the position of the rear cargo shade/partition (1) and the forward pass-through flap (2).
