# Service Bulletin

Bulletin No.: 16-NA-358

**Subject:** Buzz/Rattle Noise from Under Steering Column

| Brand: | Model: | Model Year: | | VIN: | | Engine: | Transmission: |
|---|---|---|---|---|---|---|---|
| Chevrolet | Camaro | 2016 | 2017 | | | All | All |

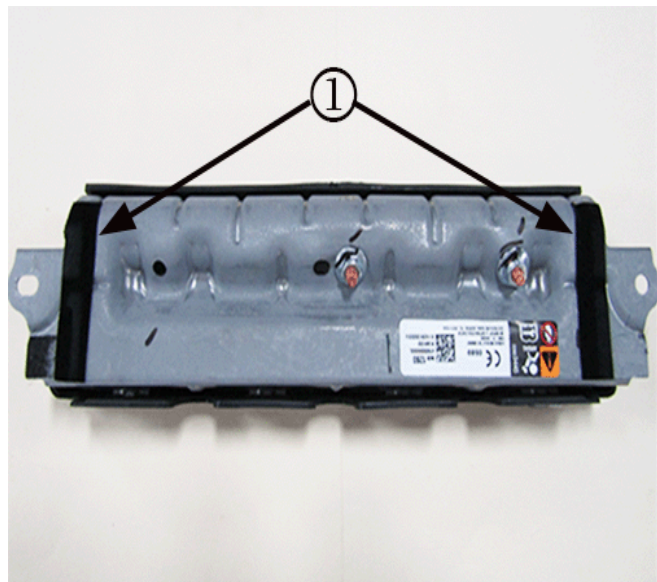
4602144

| <b>Cause</b> | The cause of the condition may be metal deposits near the driver knee air bag retaining stud, causing the surface to be slightly raised, and allowing the knee air bag to rock back and forth. When this condition is evident, there will often be witness marks visible on the top surface of the module. |

**Note:** The air bag module is shown removed from the vehicle for illustration purposes only. The BRS tape can be applied with the air bag module lowered.

Verify the condition and install BRS flocking tape (1) to the knee air bag module following the steps in the Service Procedure below.
