Service Bulletin

Bulletin No.: 16-NA-360

Subject: Sharp Edge at Bottom Rear Corner of Front Door Lower Molding

Brand:	Model:	Model Year:		VIN:		Engine:	Transmission:
		from	to	from	to		
Buick	Envision	2016	2017			All	All

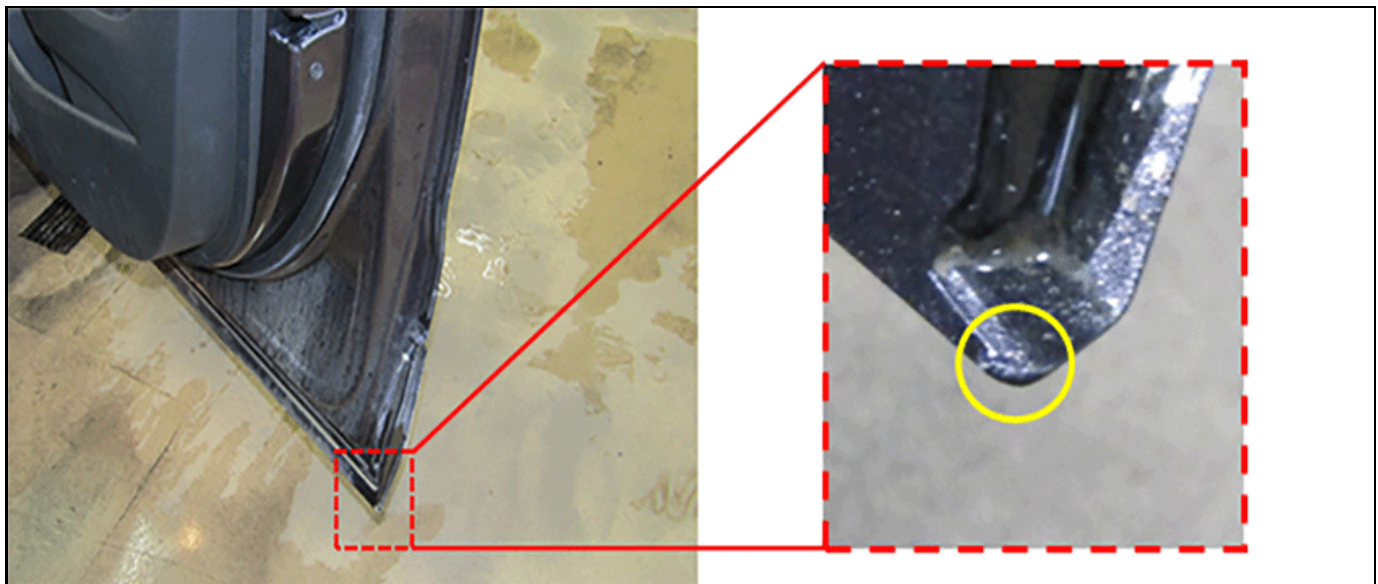
4604463

1. Open the affected front door and locate the flashing/sharp edge.
