## Model series 190 cracking between loading floor and side trunk lining

| Topic number | LI68.30-P-063994 |
| Validity | AMG GT (190) |

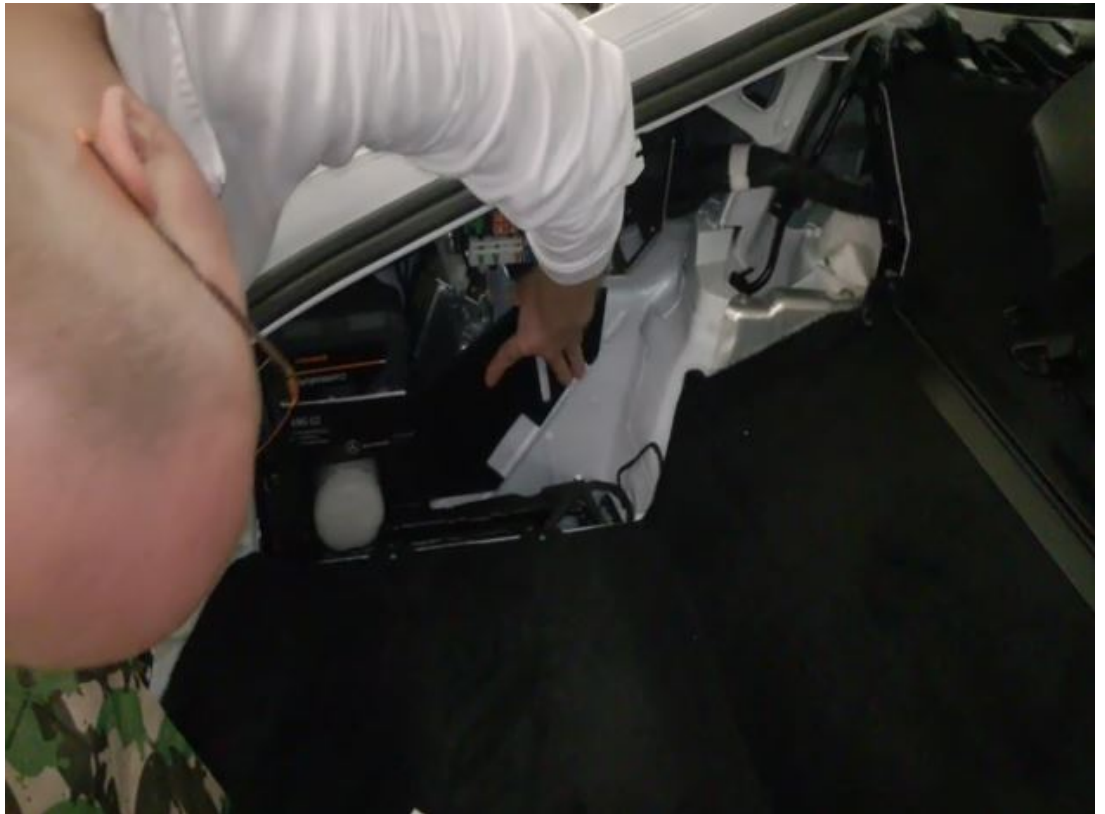
Positionierung Schablone.JPG:

Gap between loading floor and side trunk lining

Gaps that were identified in loading floor.

1. Remove lining at side of trunk, see ar68.30-p-4800rg.
2. Print out template (see Attachment) in DIN A3 format.
3. Position template, see picture 1.
4. Position block of foam, see picture 2, Position A and B. press firmly on.
