## Backrest flap mechanism on 2nd seat row nonfunctional or sluggish

Topic number	LI91.12-P-063995
Version	1
Design group	91.12 Rear seats
Date	05-02-2016
Validity	166 SOP -Through VIN 4JG1668641A764238 with code 843 - Easy Entry rear seat
Reason for change	
Reason for block

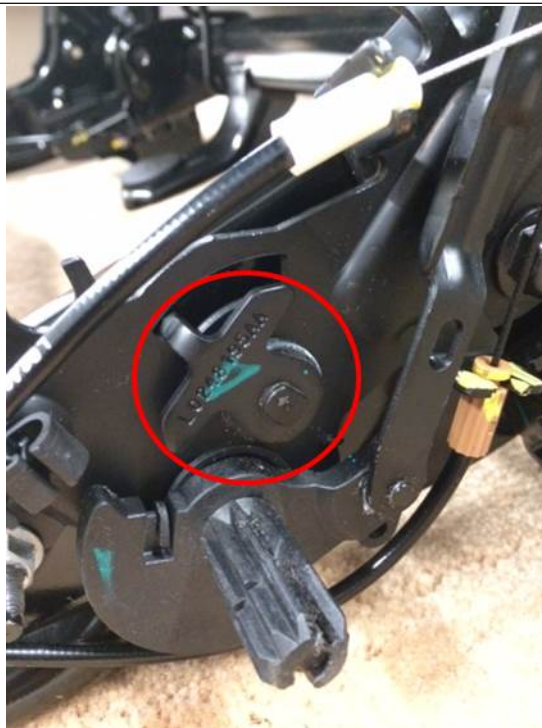
pic1.jpg:

1. Loose or incorrectly attached Bowden cables
2. Sluggishness through inhibition of flap mechanism by locking lever on seat cushion frame of 2nd seat row

Attachments	
File	Description
pic1.jpg	Locking lever from outside on 60% rear seat cushion
pic2.jpg	Locking lever from inside on 60% rear seat cushion

1. Check Bowden cable of 60%- and 40% seat on 2nd seat row is correctly mounted, if necessary hook into place and check for correct routing.
2. Removal of lock lever with spring and pin onto seat cushion frame for 60% and 40% rear seat (pic.1; pic.2). Important: Locking lever can only be removed from inside.
