## Headlamps fogged

Topic number	LI82.10-P-063240
Version	2
Design group	82.10 Exterior lights
Date	05-02-2016
Validity	Model series 117, model series 176 with SA code: 631, 632 Model series 212 SA code: 640, 641, 642 X253, model series 213 with SA code: 631, 632, 640, 641, 642
Reason for change	Model designation adapted
Reason for block

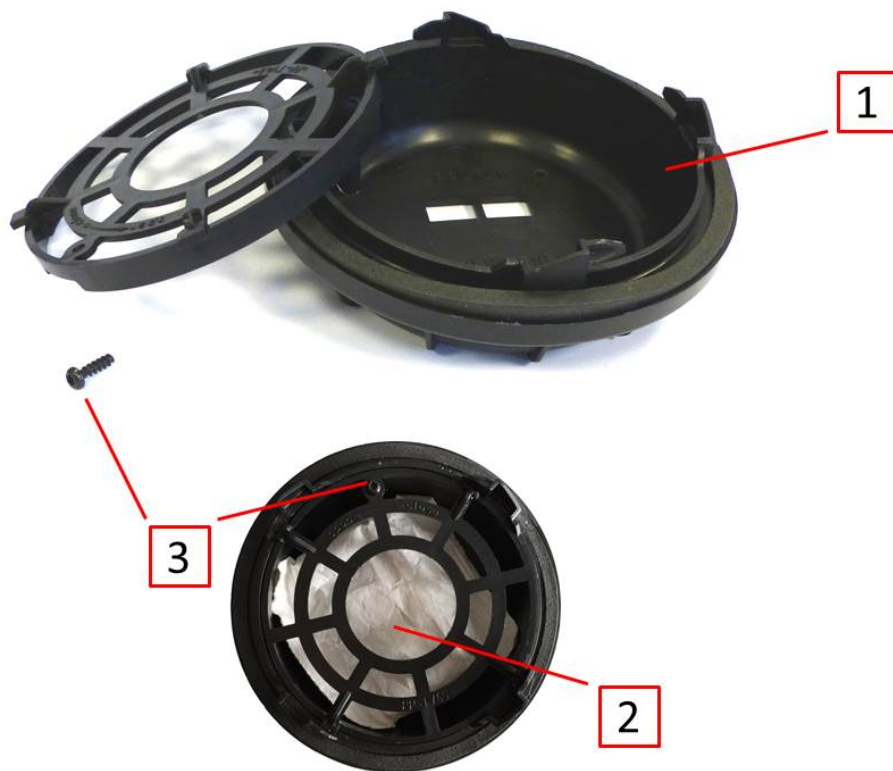
Bild\_02.jpg:

Attachments	
File	Description
Bild_02.jpg	1) Service cover for desiccant pack 2) Desiccant pack

3) Threaded connection
Bild_01.jpg	Lamp unit, model series 212

3. Place desiccant pack in new service cover and bolt down (Figure 02)
4. Stick existing membrane onto surface provided
5. Attach service cover with desiccant pack to headlamp
6. Reinstall lamp unit.
