## Interruption to playback (randomly skips tracks) of music from USB stick through KeylessGo Start.

| Topic number | LI82.85-P-064064 |
| Validity | Model series 217, 222 faulty playback of music track from USB |

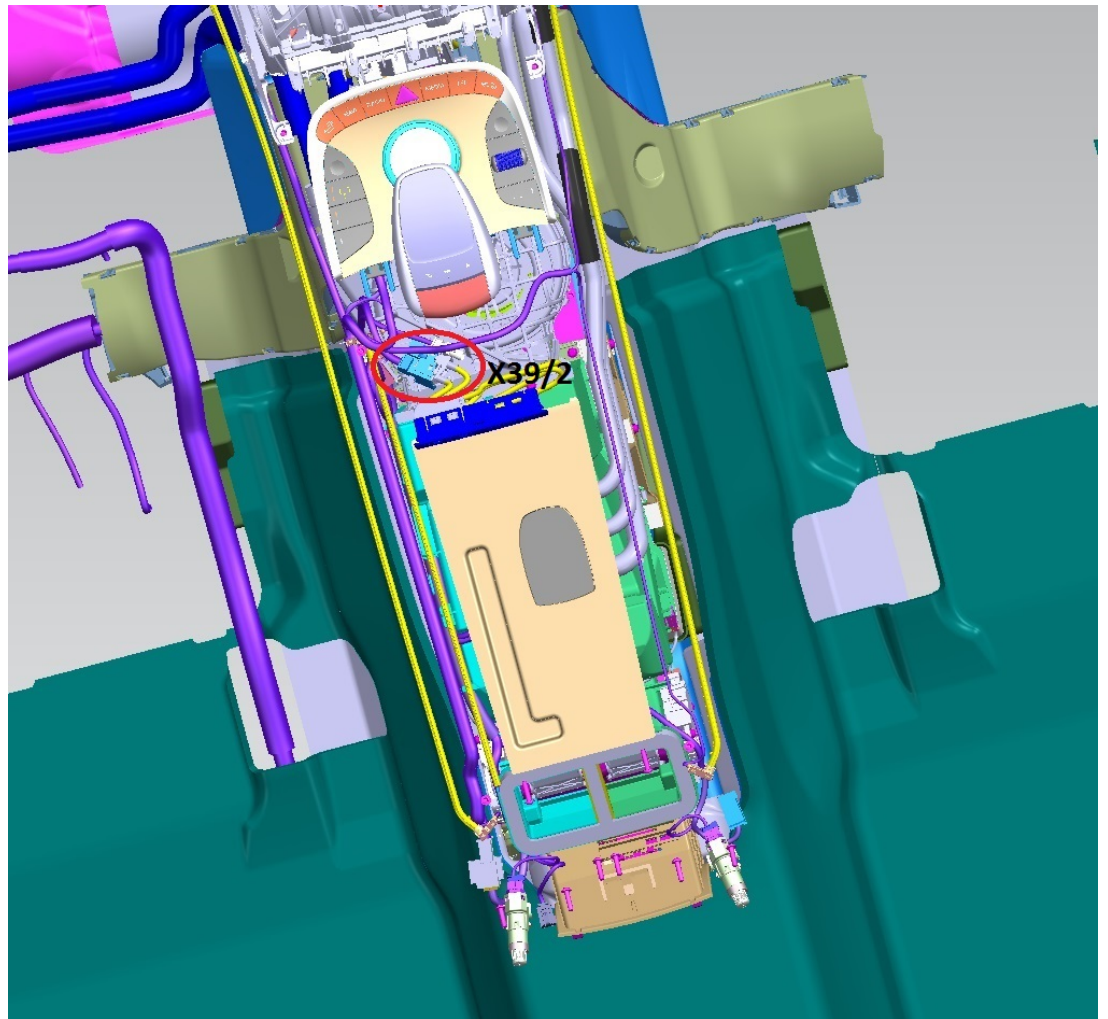
Bild1 Mittelkonsole.jpg:

Shielding for USB line not connected to correct pin on head unit (HU).

The location of connector X39/72 is available in attachments 1 and 2.

New pinning on connector X39/72 (1.) and connector A and connector B on component A40/3 (2.).

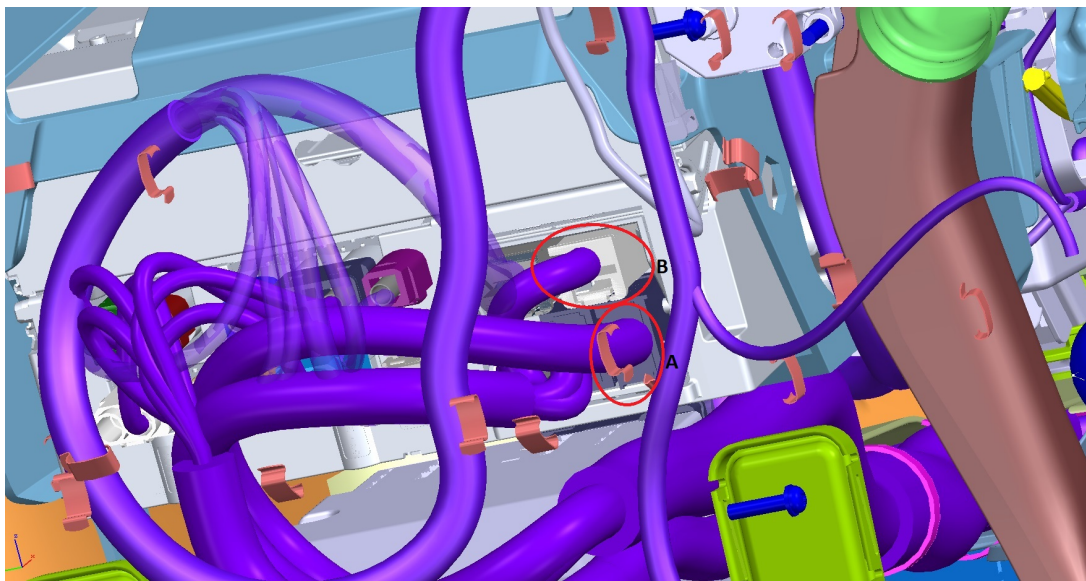
Bild3 A40-3 Stecker AB.  
jpg:

The positions of connector A and connector B on component A40/3 are available in Attachment 3.

I. Connector B: Remove pin from socket contact on connector B on A40/3

0.5 YE (Pin 8)

II. Connector A: Remove pins from socket contact on connector A on A40/3

0.5 BK (Pin 14)

0.5 TR (Pin 10)

IV. Reinstall pin contacts in new location of connector A

0.5 BK (Pin 10)

0.5 TR (Pin 13)

0.5 YE (Pin 14)
