## Cracking noises at doors in area of window frame

| Topic number | LI72.00-P-061833 |
| Validity | MODEL 205.0/2 |

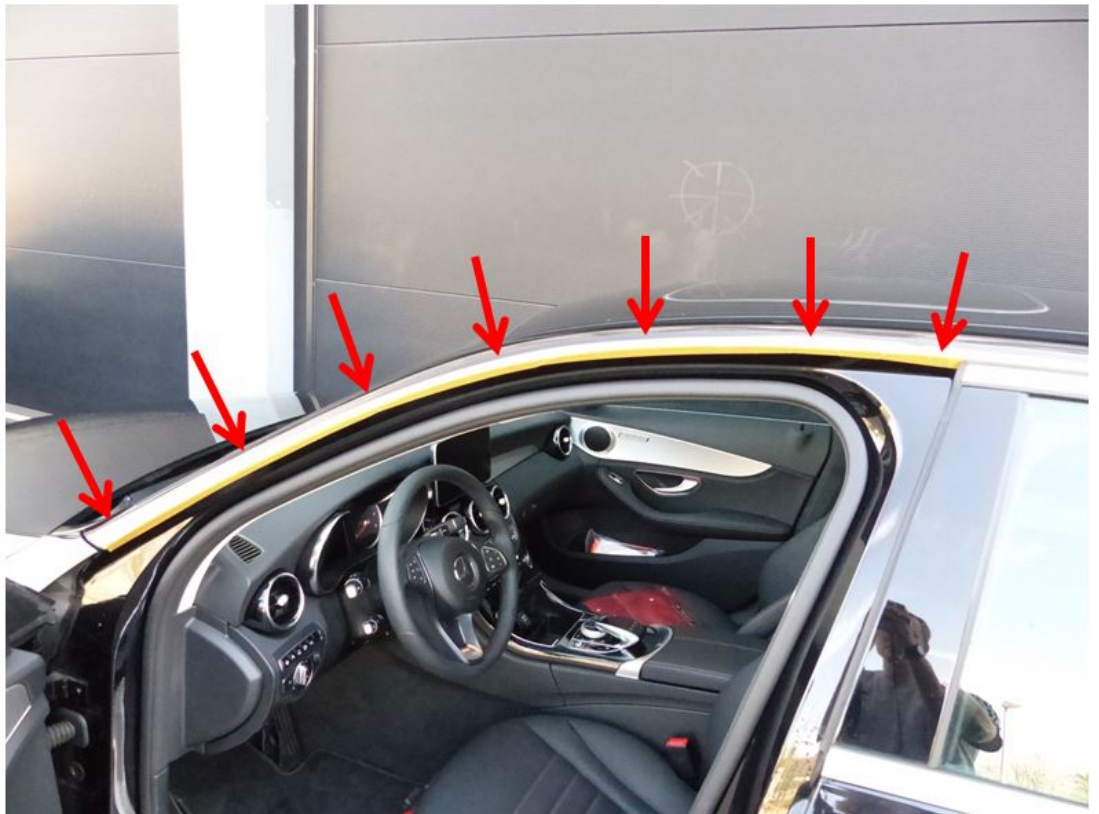
Bild 1.JPG:

1. Localize source of noise by taping up with adhesive tape, see Figures 1 and 2 (example of front door).

1.2 If the noise is no longer present after taping up, remove adhesive tape and continue with step 2.

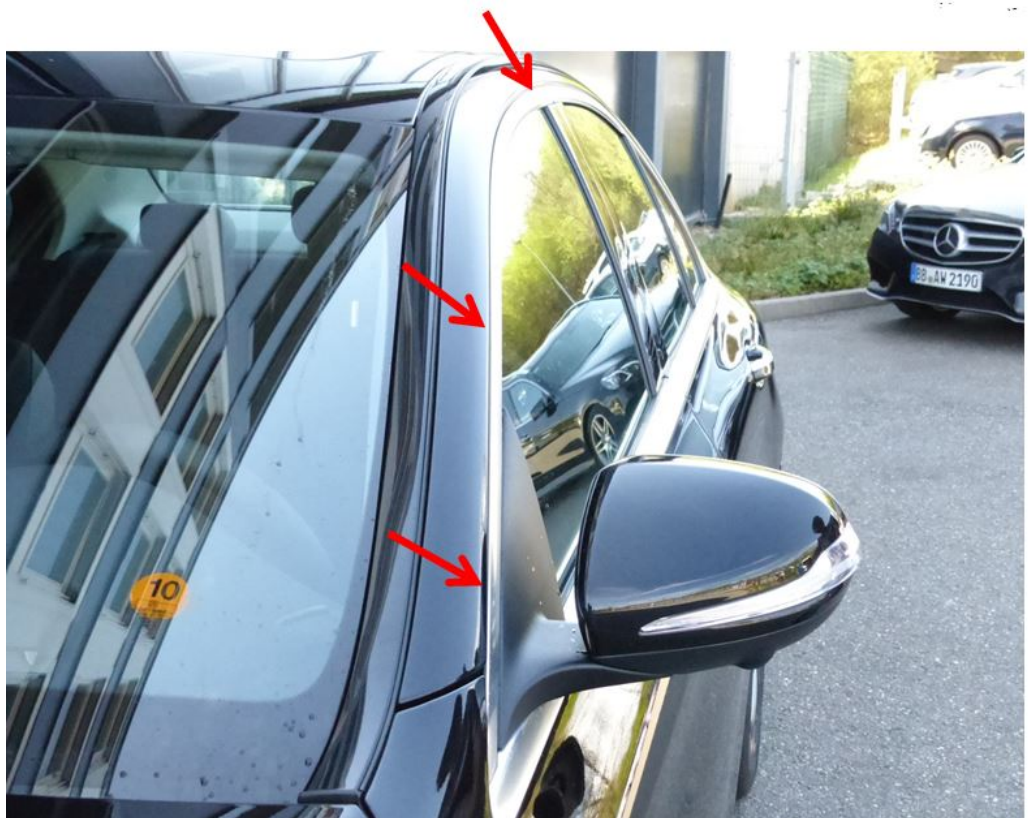
Bild 3.JPG:

2. Check transition between top of window frame and roof at the side, see Figure 3.

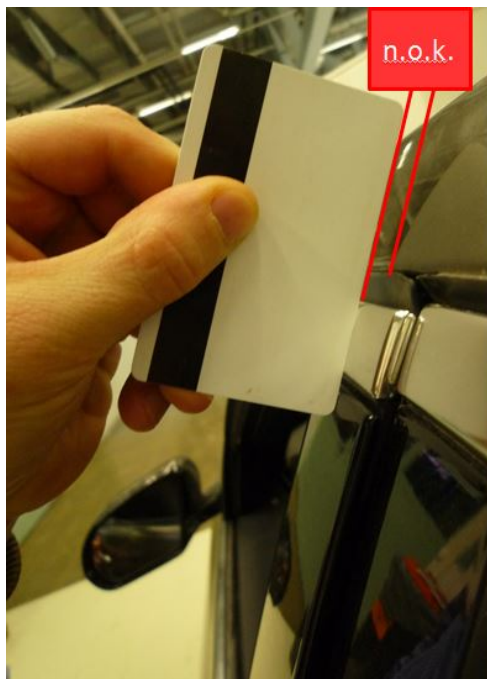
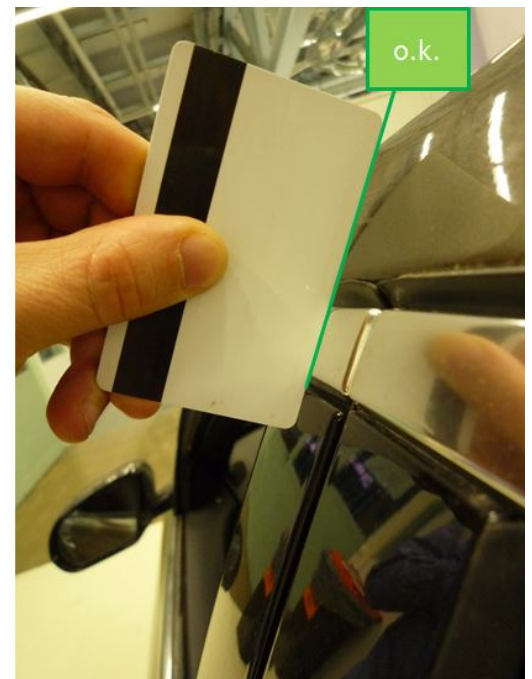
Bild 4.JPG:

Window guide rail to bodyshell clearance.

- The lip of the window guide rail must touch or be slightly lower in the area of the roof frame, see Figure 4.

Adjust the door inwards with the aid of lock striker and by loosening the hinge on the door side until the optimum setting is achieved in the area of the roof frame.

3. Replace affected window guide seals.
