# Service Campaign Bulletin

Campaign No. 2016050002, May 2016

SUBJECT: **Model 217, Model Year 2016**  
**Rework Right and Left Mounting Rail**

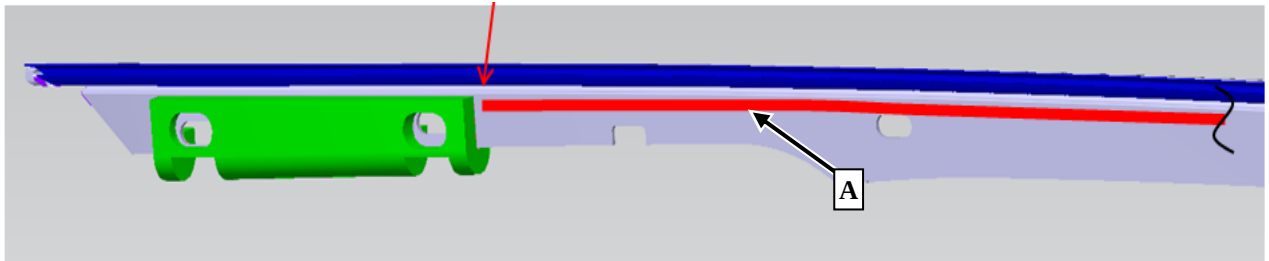
**Figure 4** (*Start of the butyl cord at the front*)

Refer to Figures 4 and 5 for the position of the butyl cord (A).

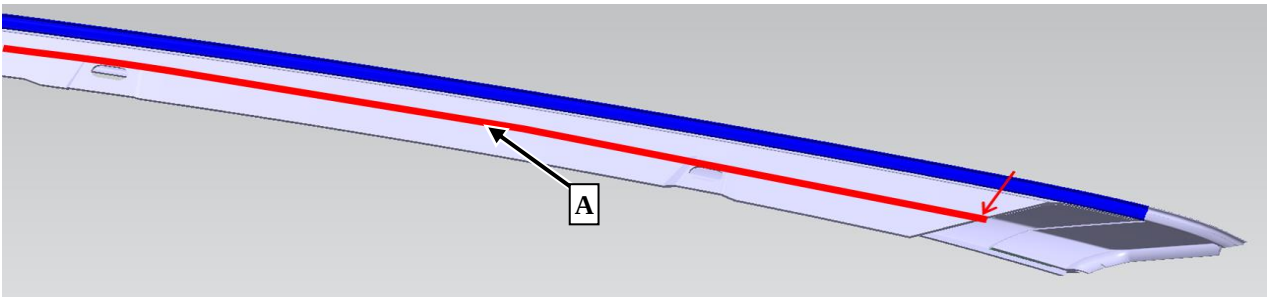
**Figure 5** (*End of the butyl cord at the rear*)
