Traces of oil in area of oil cooler (inner V) on engine 642

Topic number	LI18.30-N-056338
Version	4
Design group	18.30 Oil cooling system
Date	05-27-2016
Validity	Model 639 with engine 642 Model 906 with engine 642
Reason for change	Edit to remedy
Reason for block

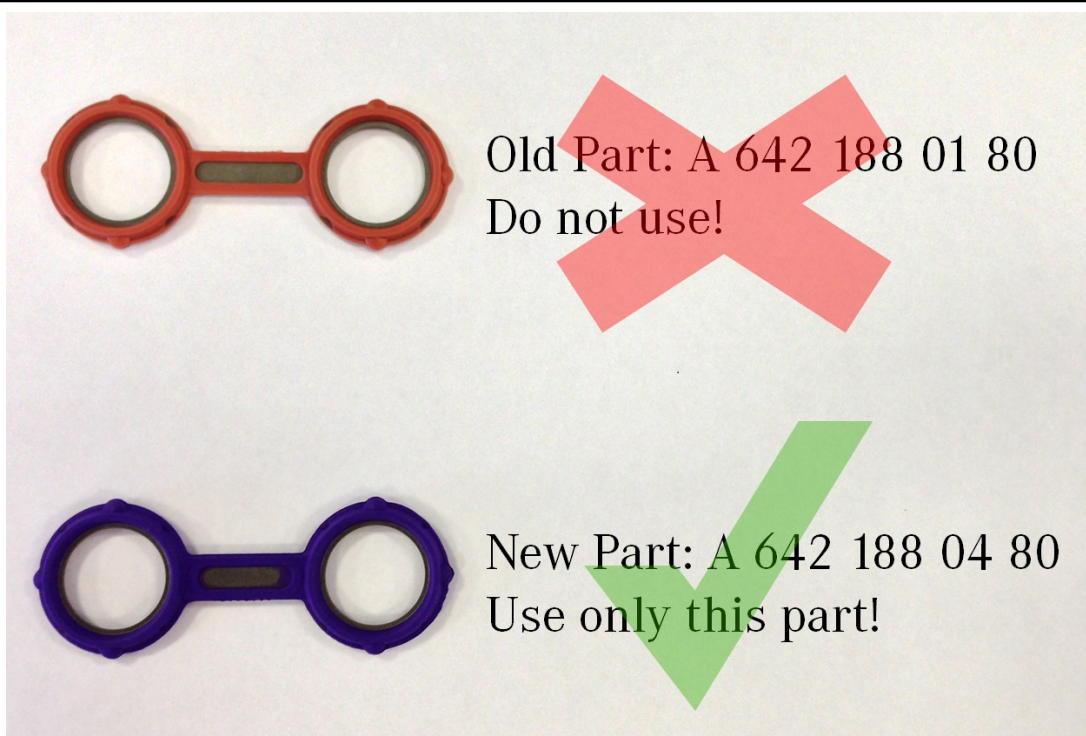
new_gasket.jpg:

Attachments	
File	Description
new_gasket.jpg	Picture of old and new gasket
Oil Cooler Top.jpg	Oil Cooler Top View. Clean around area before removing to ensure area is free of debris. Failure to do so may result in debris entering engine causing engine failure
OM 642 Turbocharger.jpg	Verify oil is not leaking from the Turbocharger Inlet Seal (175)

- 5- When replacing the oil cooler O-ring seals, ensure the new part A 642 188 04 80 is installed. See attachment "new_gasket.jpg."

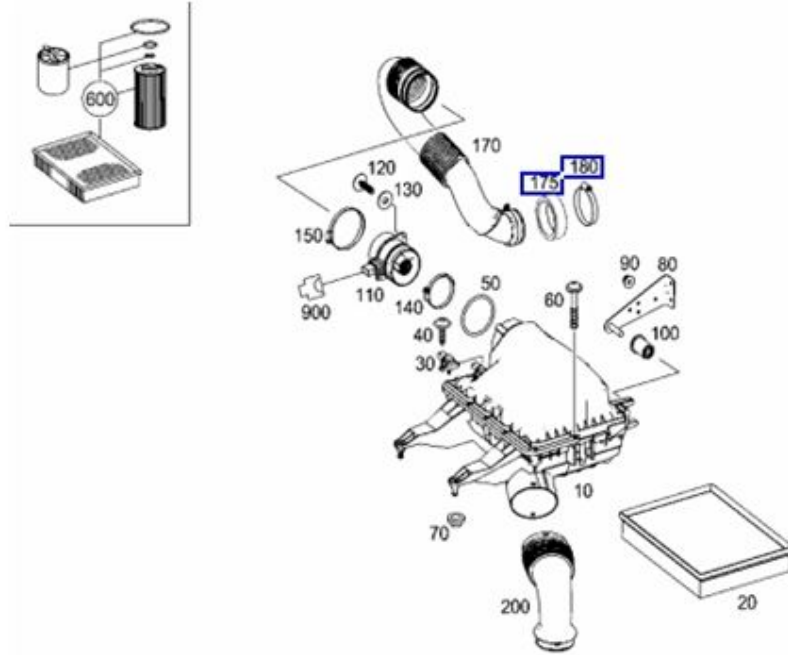
OM 642 Turbocharger.
jpg:

- 1- Oil leak from the Turbocharger Inlet Seal (175). See attachment "OM 642 Turbocharger.jpg"
- 2- Seals between engine block and oil cooler may be leaking due to incorrect installation.

- 1- Verify oil is not leaking from the Turbocharger Inlet Seal (175). See attachment "OM 642 Turbocharger.jpg"
- 2- Reference Service Bulletin V-B-09.00/01 "Operations in Clean Air Line Area"
- 3- Remove Oil Cooler; refer to WIS document "AR18.30-S-6840SE."

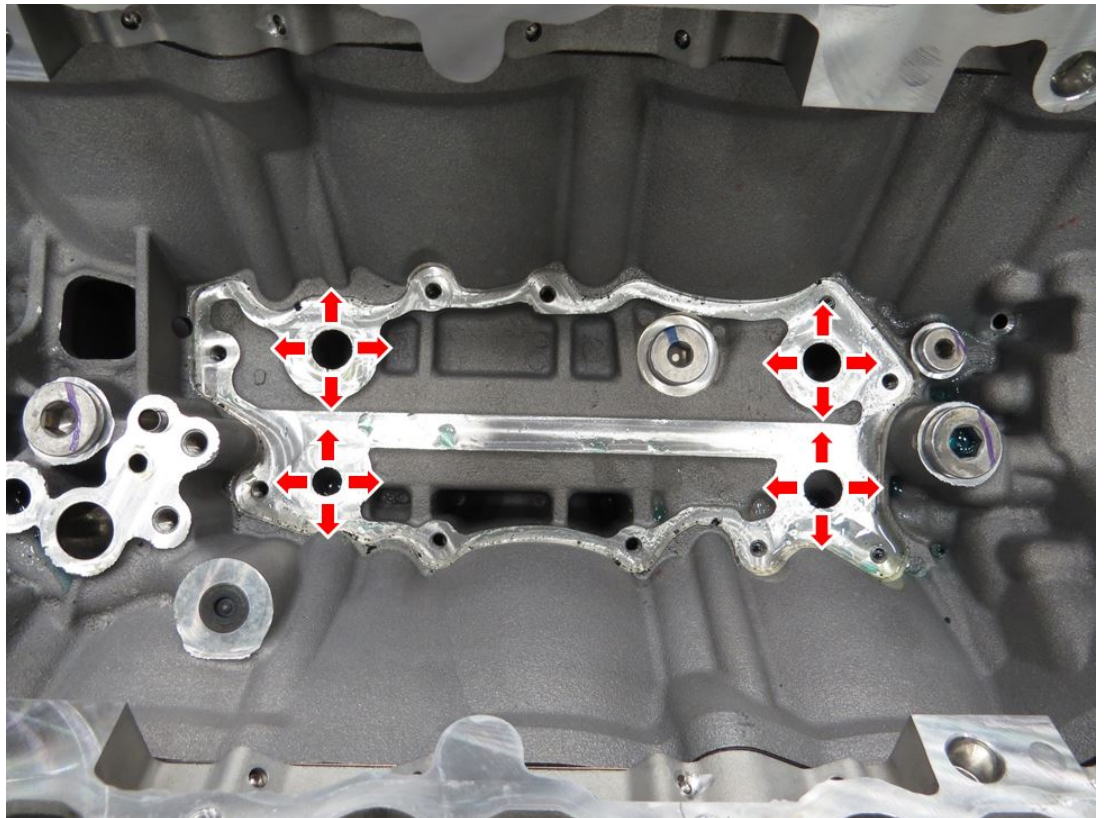
Clean away from holes.
jpg:

Clean away from the holes. Debris or fallen objects may enter the holes and cause the engine failure.

- 6- Clean residual oil around oil cooler passages in the top of the engine block.

Note: When cleaning, it is essential to start from the center of the hole and wipe outward as debris or foreign objects may enter the hole and cause engine failure. See attachment "Clean Away from holes.jpg"
