Service Campaign Bulletin

Campaign No. 2016050001, May 2016

SUBJECT: **Model 207 (Cabriolet), Model Year 2016**
Check Right A-Pillar Seam Seal, Rework if Necessary

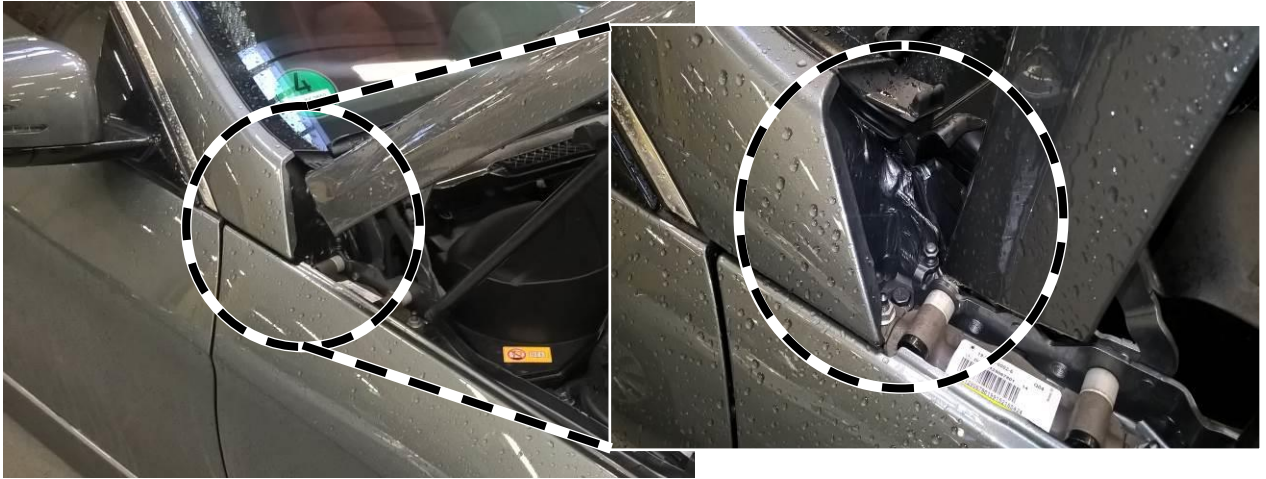
Figure 1

Check seam seal in area of right A-pillar at (Figure 1) for defects:

- If seam seal is **OK** (continuous): Procedure is complete.
- If seam seal is **NOT OK** (not continuous): Rework seam seal in area of A-pillar at right.
