## Door seal on B-pillar detaches / protrudes

| Topic number | LI68.30-P-063993 |
| Validity | MODEL 190.3## up to VIN 004769 |

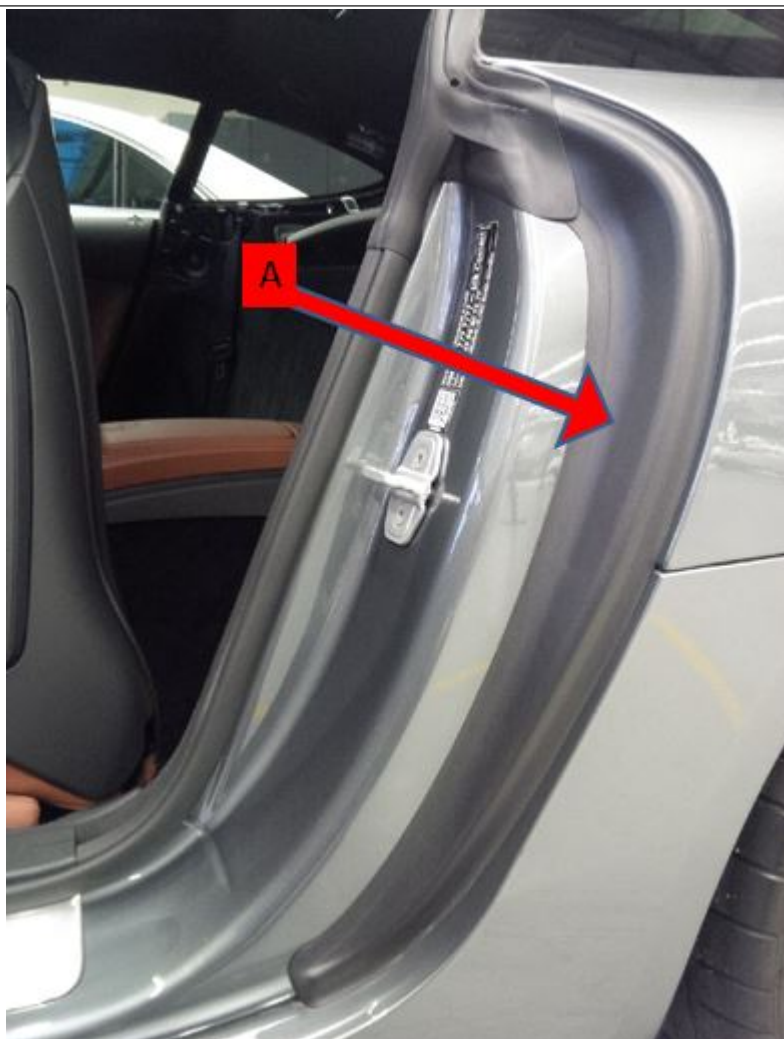
Bild B-Säule.JPG:

Door seal on B-pillar detaches / protrudes

Bonded connection

Replace component with problem (see Position A picture attachment), the faulty component is not to be reused or stuck on again.

Note: Thoroughly clean bonding surface using cleaner A0059891971.
