## COMAND Online: Unintended station or track change when cornering

| Topic number | LI82.60-P-064182 |
| Validity | Model 217/222 with COMAND Online (code 531) and code 816 (Remote control) or 864 (Rear Seat Entertainment) or 867 (SplitV) |

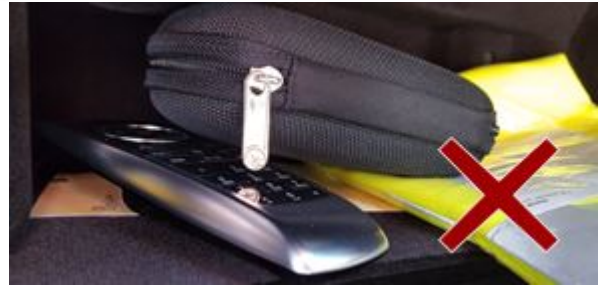
Ursache\_Fernbedienung.  
JPG:

The remote control (A8/7) for the COMAND unit (A40/3) with code 816/867 or for the Rear Seat Entertainment system (A26/18) with code 864 is operated unintentionally while cornering.

| Attachments | |
|---|---|
| Ursache_Fernbedienung.JPG | Remote control in glove compartment |

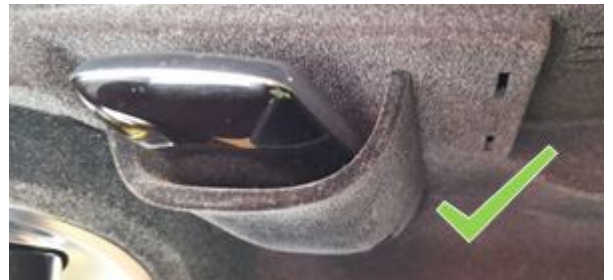
Abhilfe\_Fernbedienung.  
JPG:

| Attachments | |
|---|---|
| Abhilfe_Fernbedienung.JPG | Remote control in cradle |

Place the remote control (A8/7) in the cradle provided in the glove compartment or stow it in a place where it cannot be operated unintentionally.
