## Engine running rough / Fault code entry

| Topic number | LI54.21-P-062006 |
| Design group | 54.21 Control modules/modules |
| Validity | Model 190.37#<br>Model 205.#8# |

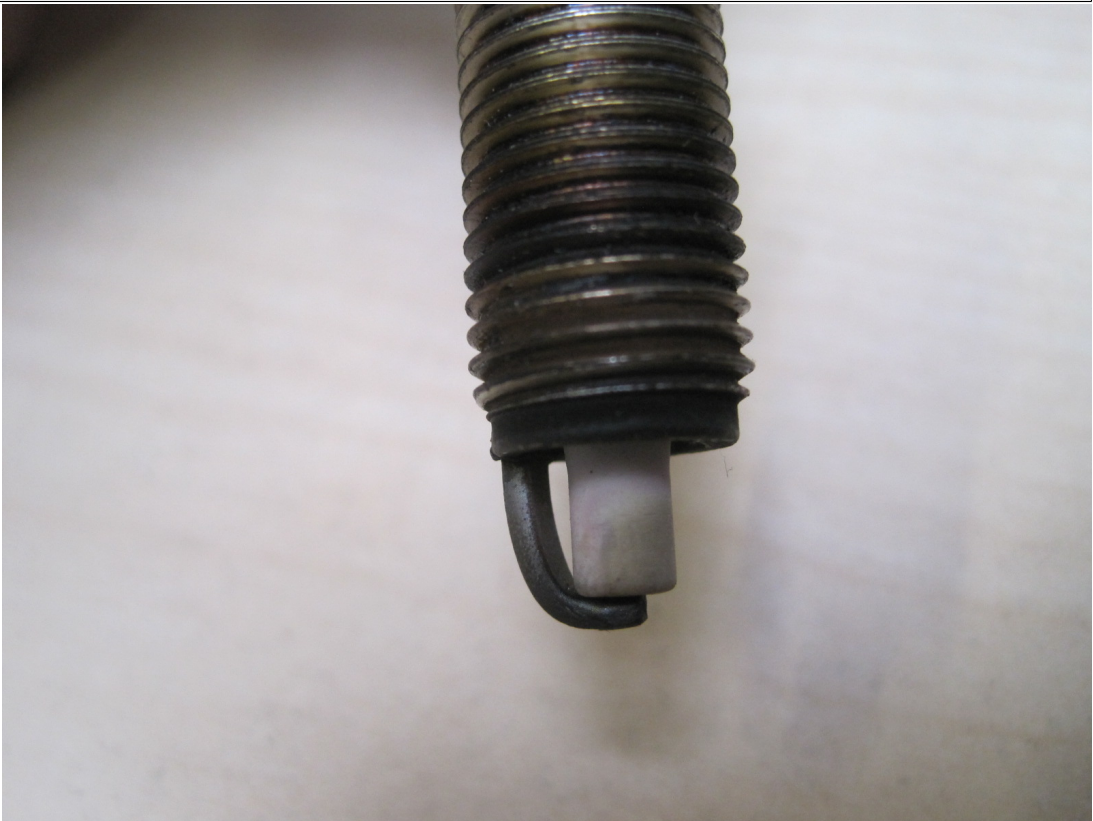
IMG\_3273.JPG:

- Check spark plugs for cracked ceramic or damaged electrode - turn the spark plug up-side down to check for cracked / lose ceramic if normally there is no visible damage (refer to attachments for example illustrations). If one or more spark plugs are found damaged, replace all spark plugs with the latest version as per EPC.
- Cross check ignition coils. If the misfire / fault moves to other cylinder(s), check / replace ignition coil packs to the latest version as per EPC

| Attachments | |
|---|---|
| IMG_3273.JPG | damaged ceramic |

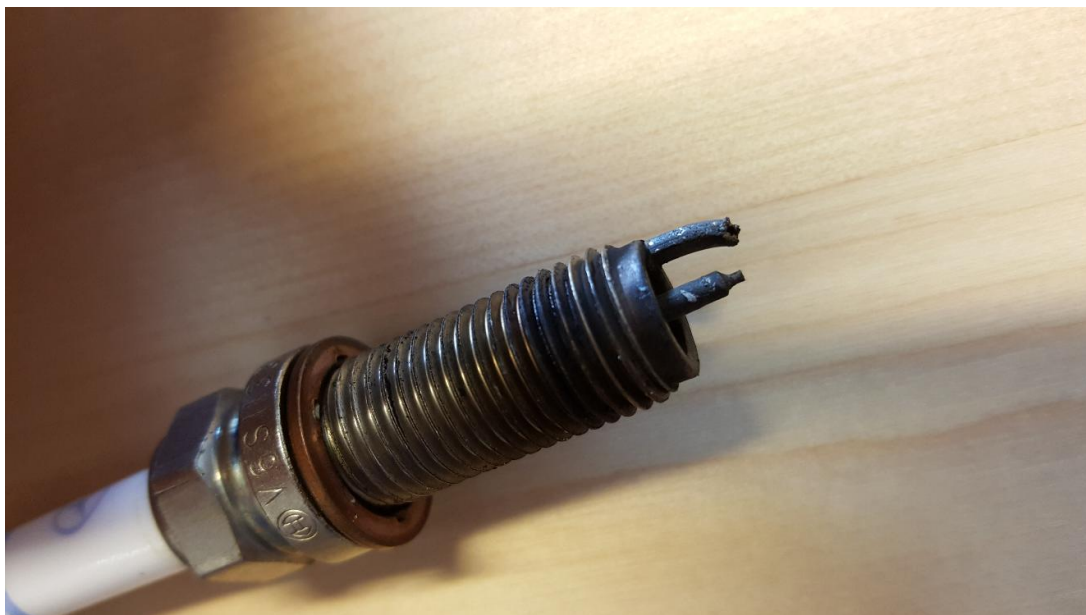
20150609\_105958.jpg:

| Attachments | |
|---|---|
| 20150609_105958.jpg | electrode damage |
