## Chafing point between wide open throttle tank regeneration line and engine trim cover

| Topic number | LI09.10-P-064290 |
| Validity | All vehicles with engine M133 up to engine no. 65252 |

# Verbau neues Teilepaket Regenerierung / Instruction new parts vent line

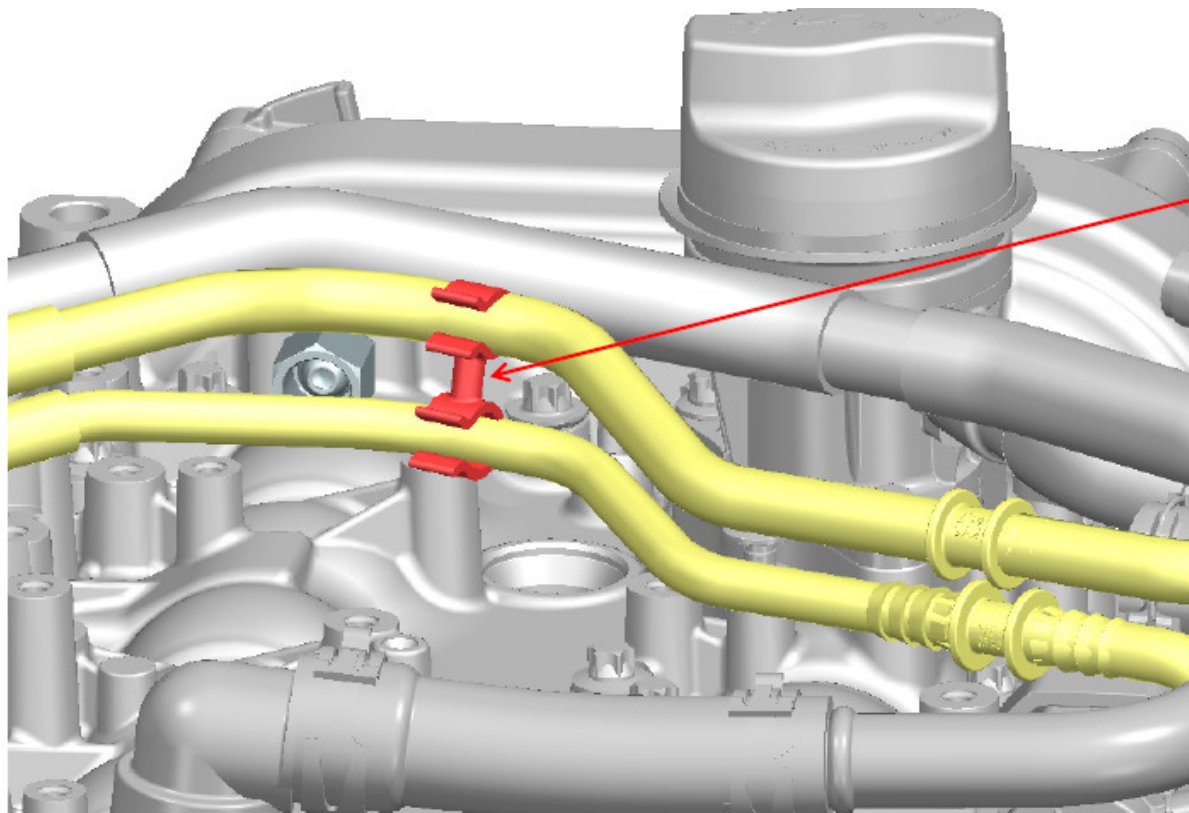
Abstandhalter zwischen den Regenerierleitungen A133 010 68 00 und 69 00 entfällt

Spacers between the new regeneration line A133 010 68 00 and 69 00 I not needed anymore

Entfall des Abstandhalter / Elimination from the  
Spacer A000 995 05 75

- 1.) The clip (red) A000 995 05 75 is no longer required. See page 2 of attachment.
- 2.) The spacer A000 520 01 67 remains in the old position. See page 3 of attachment.
- 3.) The two new lines are now fastened to the expansion reservoir and positioned with 2 clips each. See page 4 of attachment.
- 3.A.) Because of this, the two spacer rings A001 997 06 44 at the previous locations are no longer required. See page 4 of attachment.
- 4.) One additional spacer A133 010 69 00 is installed. See page 5 of attachment.

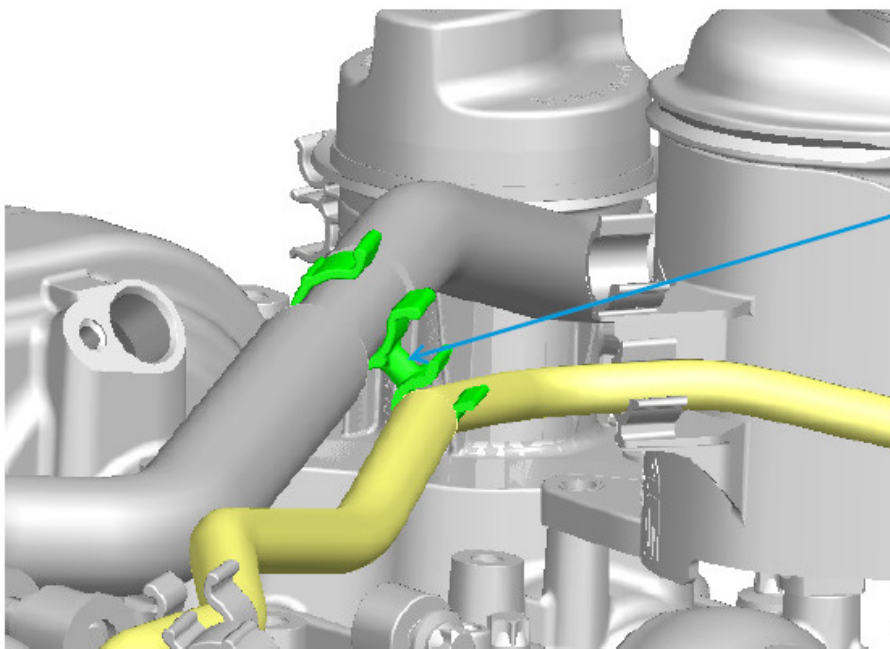
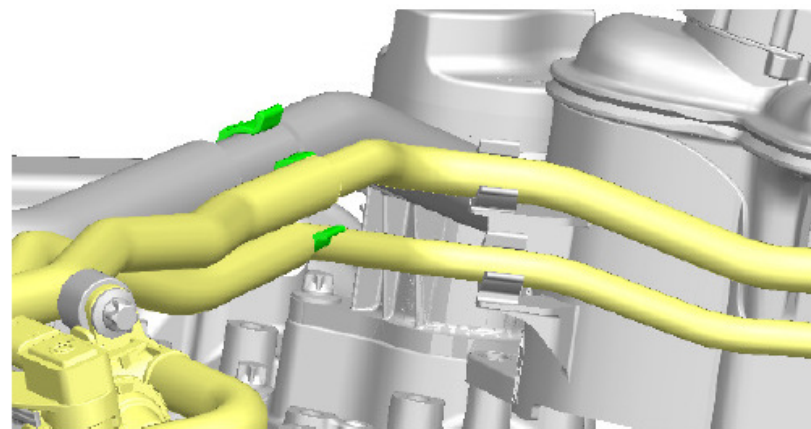
Verbleib Abstandhalter zwischen Regenerierleitung A133 010 68 00 und Entlüftungsleitung

Whereabouts spacers between the new regeneration line A133 010 68 00 and the vent

Abstandhalter A000 520 01 67 unverändert gegenüber bisherigem Verbau  
Spacers A 000 520 01 67 unchanged from previous course

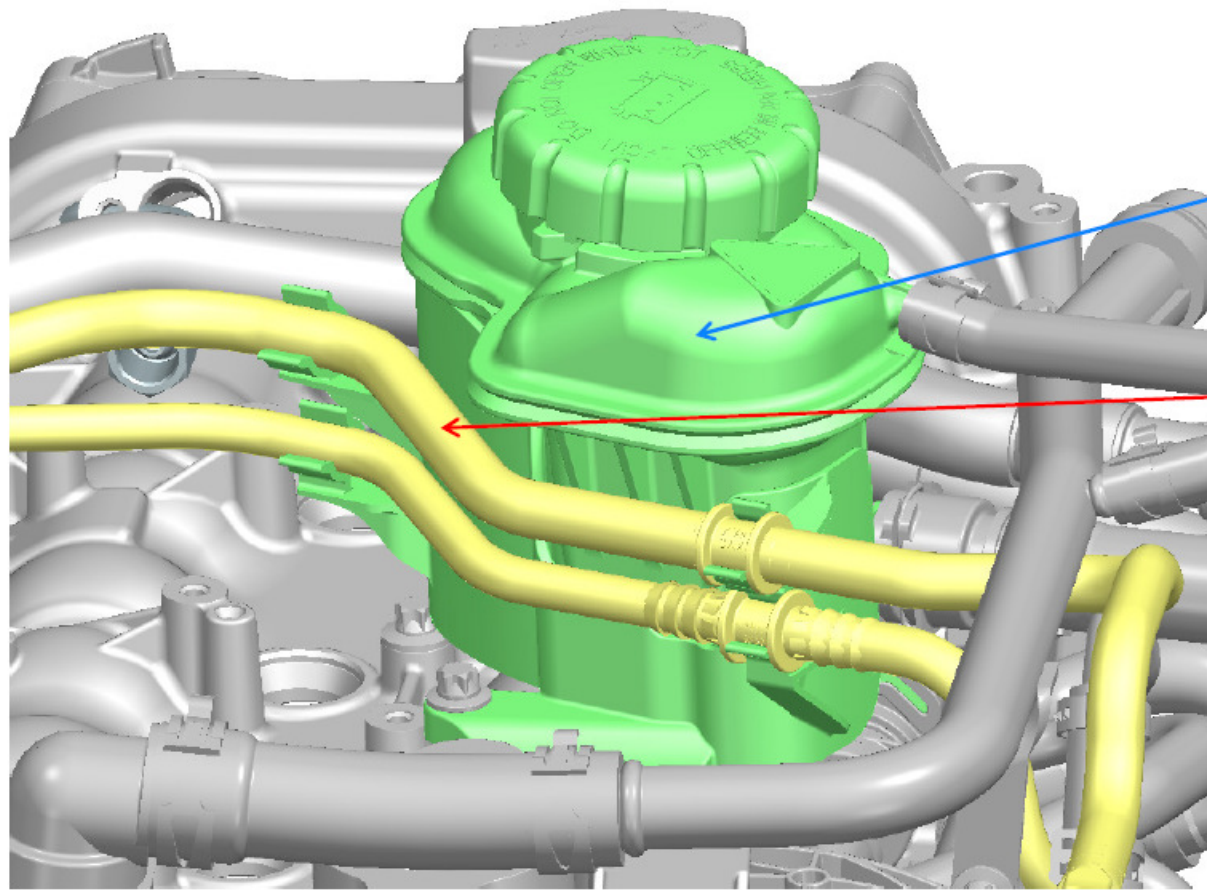
Neuer Ausgleichbehälter A133 200 00 85 und neue Regenerierleitungen A133 010 68 00 und 69 00

New cooling reservoir A133 200 00 85 and new vent lines A133 010 68 00 and 69 00

Neuer Ausgleichbehälter / New cooling reservoir A133 200 00 85

Entfall der Abstandsringe / Elimination of the rubber spacers A001 997 06 44

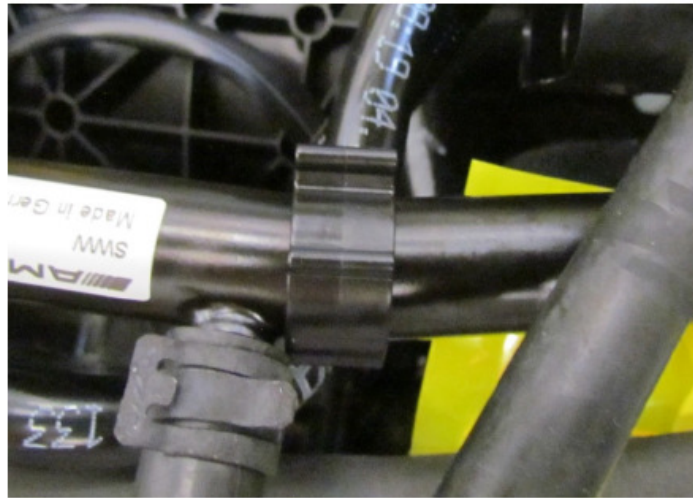
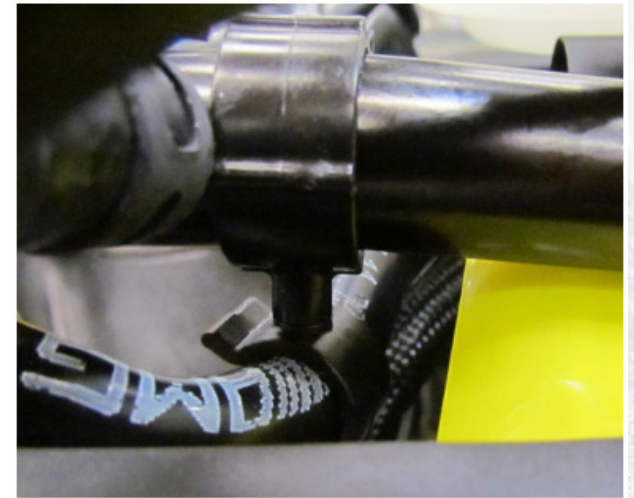
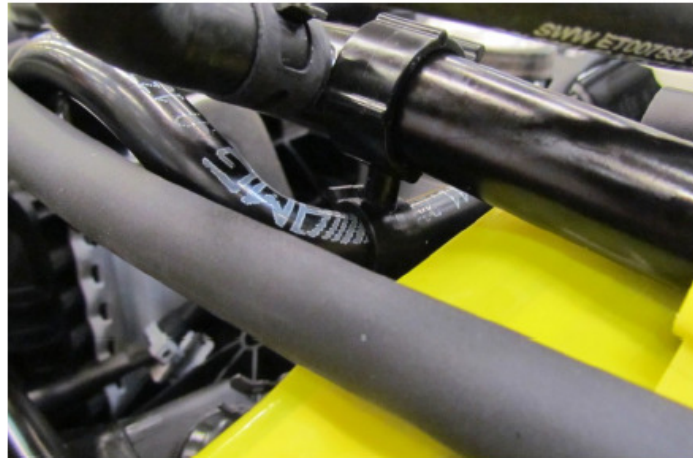
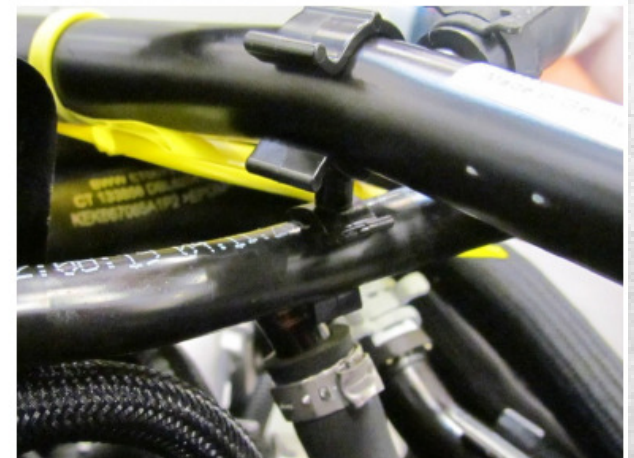
Montieren eines neuen Abstandhalter / Install new spacer to regeneration line

Verwendung eines Abstandhalter für einen definierten Abstand zwischen der Kühlwasser-Rücklaufleitung des Ladeluftkühlers und der Regenerierleitung  
/ Using a spacer for a defined distance between the cooling water return pipe of the intercooler and the regeneration line  
A000 995 29 75
