Customer ONE Action

Date: June 2016  
Action No.: C1A160601  
Group: 46

SUBJECT: **Model 213**  
**Model Year 2017**  
**Check Steering Column, Replace if Necessary**

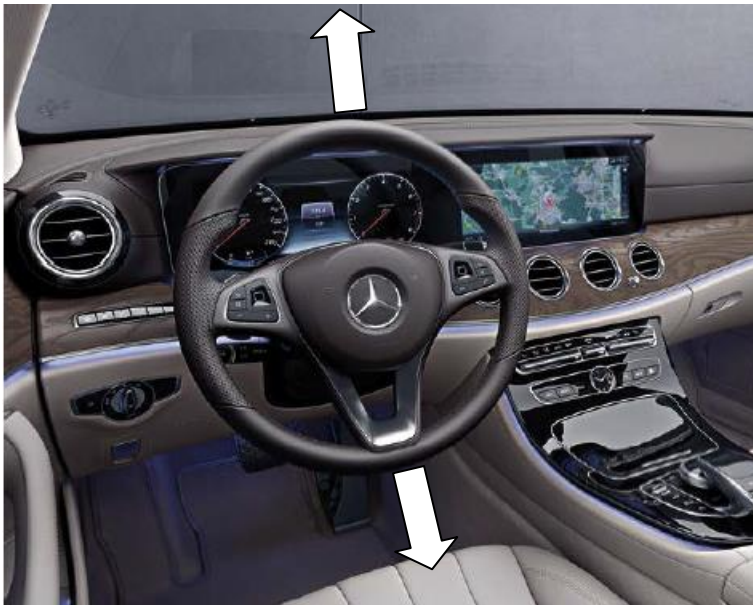
Figure 1

Get a good grip with both hands on the 6 o'clock position of the steering wheel and check the steering column for increased axial play in the up and down direction (arrows, Figure 1). Audible clicking will be heard if axial play is present.

**Note:**  
Axial play reaches up to 5 mm.
  - If **no** axial play with clicking noise is found (**OK**): Procedure is complete.
  - If axial play with clicking noise **is** found (**NOT OK**): Proceed to step 2.

2. Open a PTSS case in the event that the steering column requires replacement and wait until guidance is provided by FTS.

If instructed to replace steering column by FTS, refer to WIS: AR46.10-P-0400LW.
