## Pop-up roof wind deflector, whistling noise with glass panel open between approx. 40 and 80 mph

| Topic number | LI77.21-P-064406 |
| Design group | 77.21 Panoramic roof |
| Validity | W213 with code 413 (Panoramic roof) from production date 09.05.2016 up to and including 15.06.2016 |

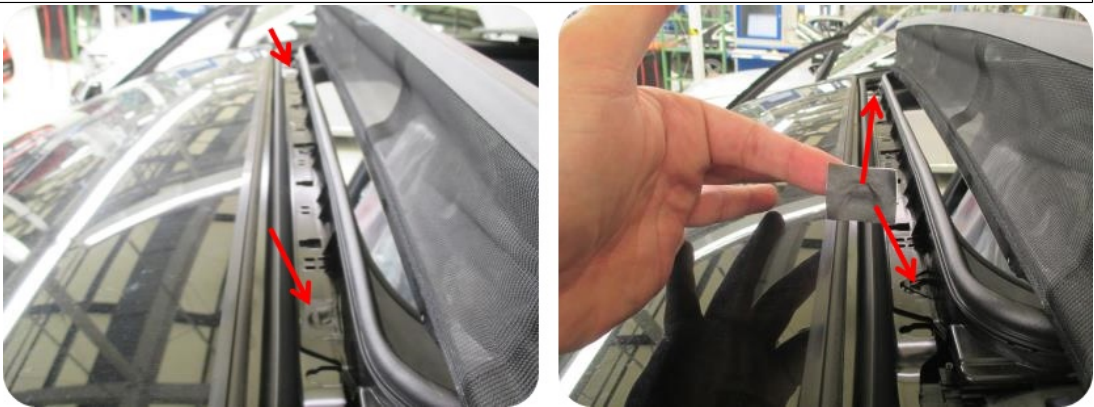
Bild\_Laschen Windabweiser li-re.jpg:

Due to "vibration" of the headliner fixing clip (pop-up roof), a whistling noise can occur in the area of the wind deflector at speeds of approx. 40 and 80 mph (70 and 130 km/h), see Figure 1

| Attachments | |
|---|---|
| Bild_Laschen Windabweiser li-re.jpg | Figure 1 |

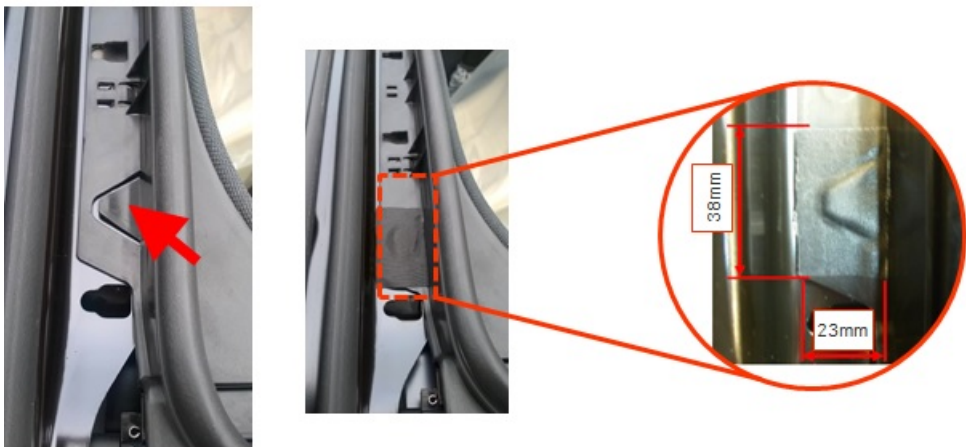
Bild\_Lasche Windabweiser\_Klebepad bemaßt.jpg:

| Attachments | |
|---|---|
| Bild_Lasche Windabweiser_Klebepad bemaßt.jpg | Figure 2 |

- 1) Remove wind deflector, see AR77.21-P-0100LF
- 2) Attach adhesive strips to the left and right headliner fixing clips, see Figure 2
- 3) Install wind deflector, see AR77.21-P-0100LF

| Part number | ES1 | ES2 | Designation | Quantity | Note | EPC |
|---|---|---|---|---|---|---|
| 046510050500 | | | Tesa(R) Premium fabric tape 25 mm x 50 m black | 1 | Two pieces 38mm x 23mm are required for each repair | |
