## Engine noise (rattling) after engine start

| Topic number | LI05.10-N-057796 |
| Design group | 05.10 Timing chain drive, toothed belt drive |
| Validity | ENGINE 651 in model 900, 906, 636, 639 |

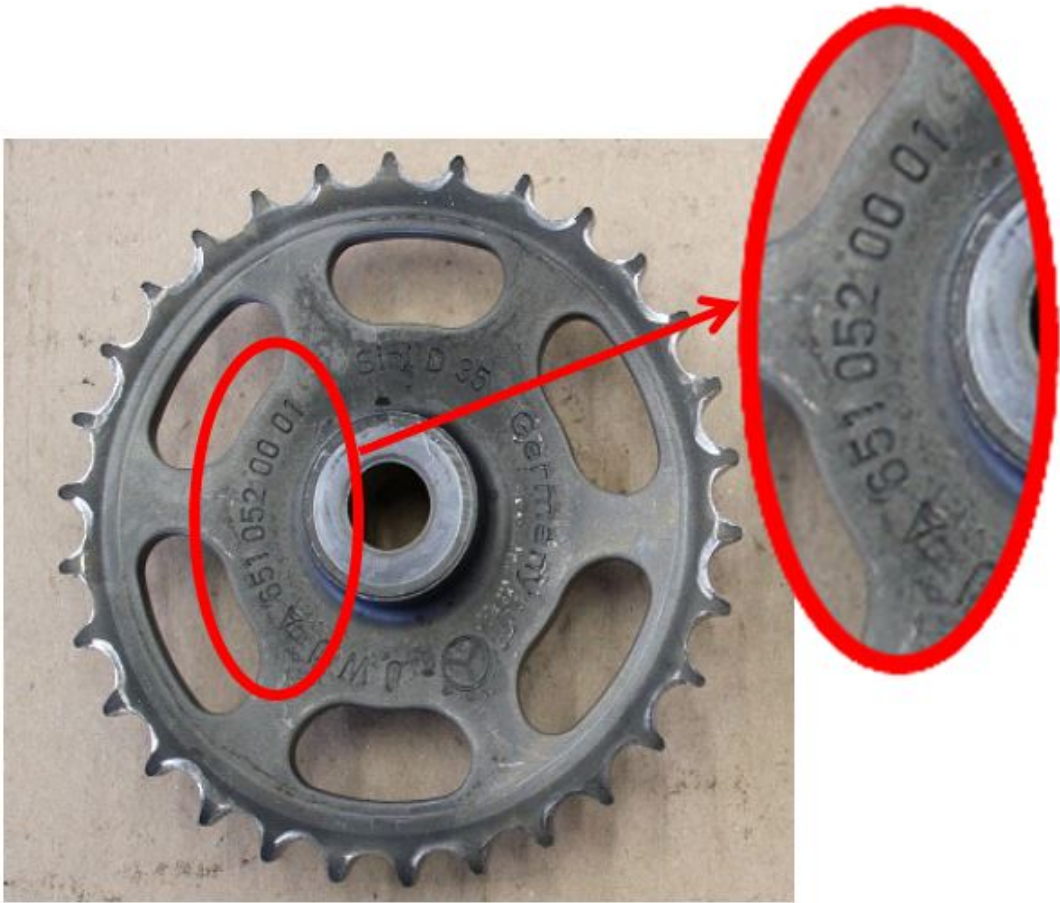
01.jpg:

Camshaft sprockets with the object number A 651 052 00 01 are to be replaced by A 651 052 00 00 (AR05.20-D-6992-08WE).

Camshaft sprockets with object number A 651 052 00 00 may only be replaced if they are seriously worn (pitting, broken tooth tips). An intact sprocket has a uniformly polished surface at the chain inlet; this is not grounds for replacement.

The object number is clearly visible on the camshaft sprockets (see picture in attachment).

| Attachments | |
|---|---|
| 01.jpg | Part number of camshaft sprocket. |
