| RE: <b>Service Campaign 2016070004</b><br><b>Model 253, Model Year 2016</b><br><b>Check Rear Window Seal, Rework if Necessary</b> | DATE: July 29, 2016 |

# Service Campaign Bulletin

Campaign No. 2016070004, July 2016

SUBJECT: **Check Rear Window Seal, Rework if Necessary**  
**Model 253, Model Year 2016**

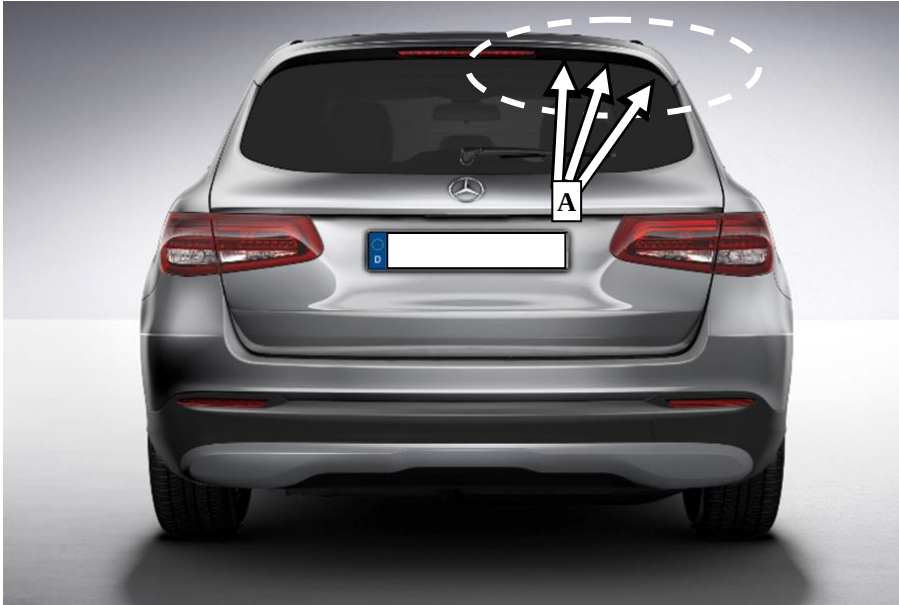
Figure 1

Daimler AG (DAG), the manufacturer of Mercedes-Benz vehicles, has determined that on certain GLC-Class vehicles (253 platform), the bonding of rear window seal might not meet current specifications. An authorized Mercedes-Benz dealer will first check the rear window seal, and rework, if necessary.

1. Perform water leak test on rear window in marked area (A, Figure 1):  
Direct water stream for approx. 3 min. onto the rear window **under** the roof spoiler in area A.

Check rear window and tailgate from inside for signs of water leakage:
  - Visible water drips on the inside of the window or
  - Escaping water visible in the lower area of the tailgate paneling.
  - If there is **no** water leak detectable (**OK**): Procedure is complete.
  - If water leak **is** detected (**NOT OK**): Proceed to

Remove rear window and glue in again, refer to WIS

: AR67.20-P-5145LW.
