| RE: <b>Service Campaign 2016070002</b><br><b>Models 166, 205; Model Years 2016</b><br><b>Replace Collision Prevention Assist (CPA)</b><br><b>Sensor</b> | DATE: July 29, 2016 |

Campaign No. 2016070002, July 2016

SUBJECT: **Models 166, 205; Model Years 2016**  
**Replace Collision Prevention Assist (CPA) Sensor**

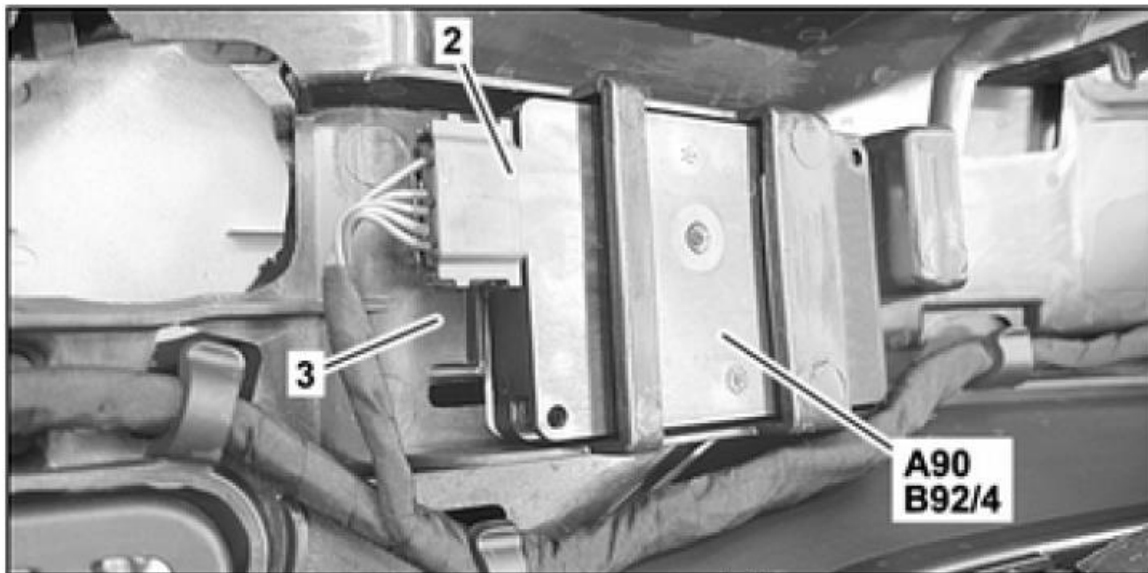
| AR30.30-P-1210LW | Remove/install radar sensor | 1.9.15 |

- Correction to step 4 (this will be corrected in a future WIS release):

“4. **Push down on locking tab (3)** and remove front left bumper radar sensor (B92/3) or front right bumper radar sensor (B92/4) or COLLISION PREVENTION ASSIST controller unit (A90)”.
