## Wind noise/howling in excess of 120mph at front door/A-pillar at left/right

| Topic number | LI72.10-P-064593 |
| Design group | 72.10 Front door |
| Validity | MODEL 213 up to VIN end no.:<br>A 019195;<br>L 000125;<br>Z 003412; |

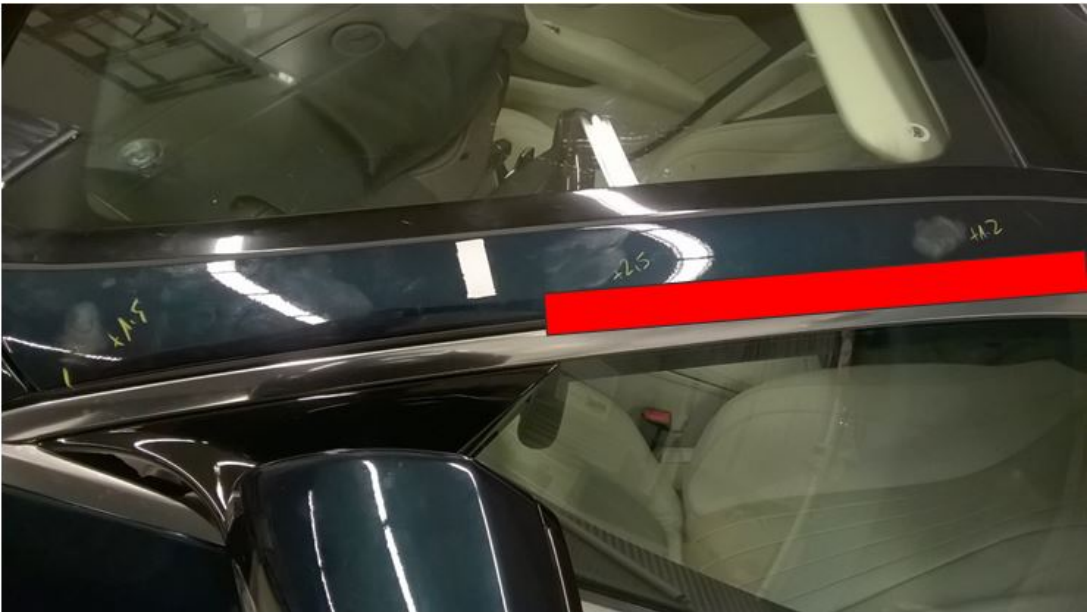
Bild1.JPG:

The forward lip of the window guide rail trim strip may separate at high speeds.

To do so, mask off window guide rail on A-pillar as from area level with mirror triangle, see Picture 1.

If the noise can no longer be heard after masking off the area, the trim strip on the window guide rail must be replaced.
