# Service Campaign Bulletin

Campaign No. 2016030009, April 2016

SUBJECT: **Model 205, Model Year 2016**  
**Correct Torque of Transmission Mount Cross Bar Bolts**

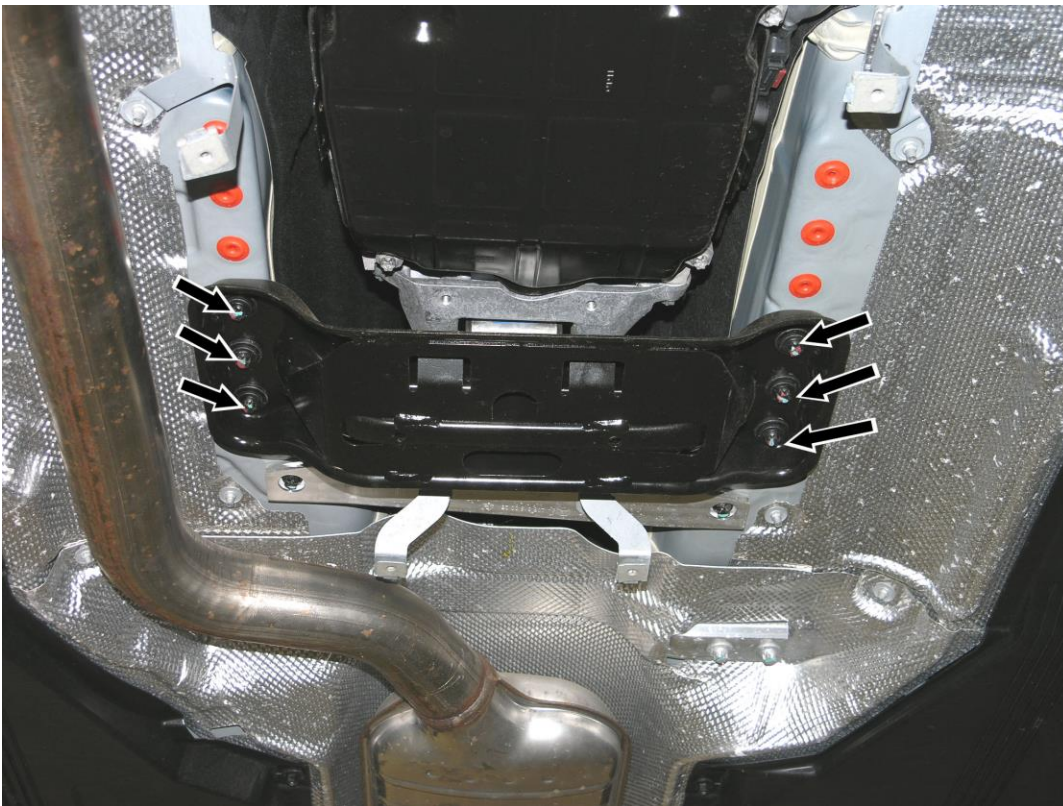
Figure 2

This Service Campaign has been initiated because Daimler AG (DAG), the manufacturer of Mercedes-Benz vehicles, has determined that, the bolt torque for the transmission crossbar mount may not have been tightened to production specifications. Noise may develop in the area of the rear transmission mounting during acceleration/deceleration or at low outside temperatures. An authorized Mercedes-Benz dealer will correct the bolt torque at the transmission crossbar mount.

Torque transmission mount crossbar bolts (arrows, Figure 2) to 50 Nm.
