## Complaints about engine rough running characteristics, possibly various fault codes logged in engine control unit

| Topic number | LI54.18-P-063779 |
| Design group | 54.18 Cable harnesses |
| Validity | Model 205 with engine 274<br>(Production date up to January 3, 2016) |

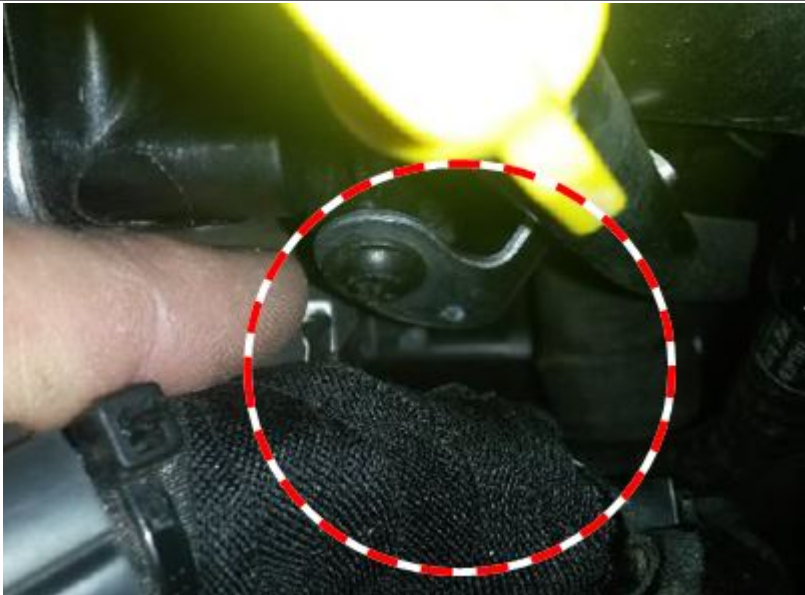
Bild 1.JPG:

The engine wiring harness could be touching, rubbing at the oil dipstick bracket.

- Check wiring harness in area of oil dipstick (Figure 1) for possible damage (Figure 2).

Open the wiring harness in this area and carefully check all wires!

- Repair the wiring harness if necessary (AR00.19-P-0100A must be observed!)
