## smart audio system - There is an error in the audio system

| Topic number | LI82.60-P-063836 |
| Design group | 82.60 Radio, audio/video systems |
| Validity | BR453 with smart audio system, SA code 537/561/505/562 |

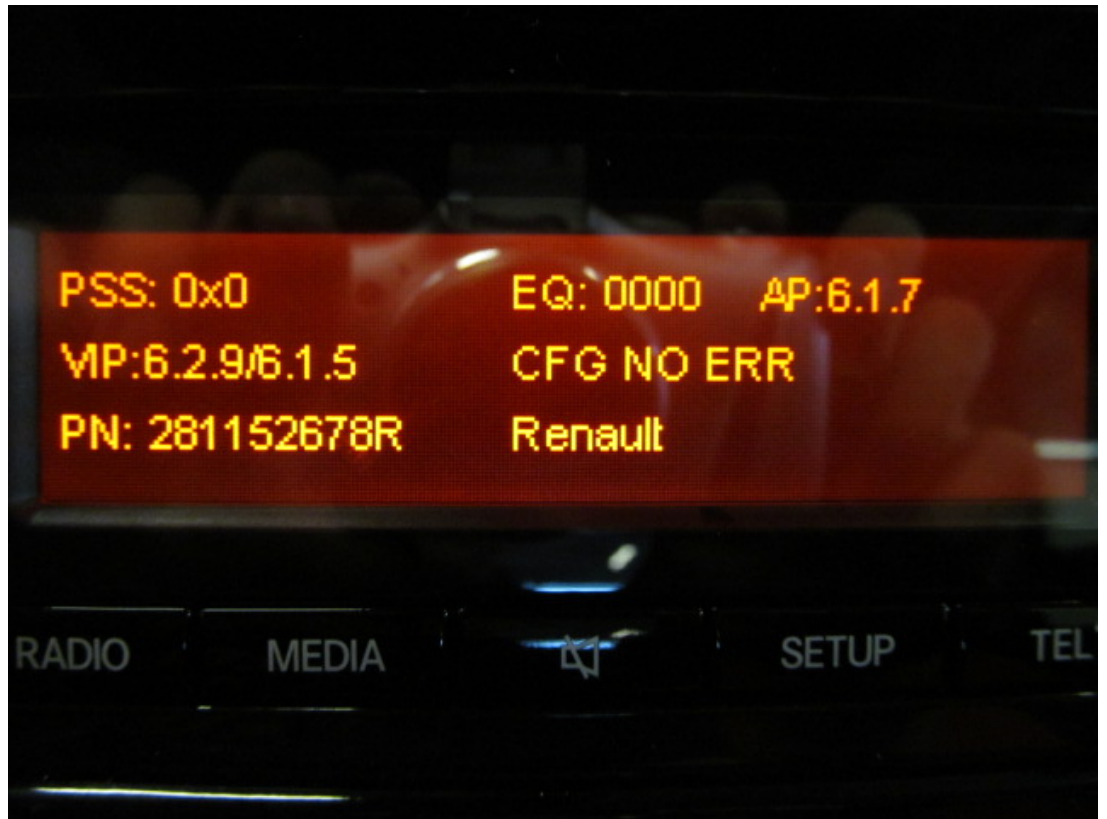
IMG\_2513[1].JPG:

There is an error in the Audio radio (A2) or a display message similar to that in the attachment.

| Attachments | |
|---|---|
| IMG_2513[1].JPG | Display message |

USB software incomplete after the Audio radio (A2) was flashed with Xentry Diagnostics.

Note: After updating the software of the Audio radio (A2) with Xentry Diagnostics, always perform an update of the USB software.

Download the software from the Xentry Portal and install the software on the Audio radio (A2) via a USB stick.
