## Seat cover appears stained or soiled

| Topic number | LI91.18-P-063341 |
| Validity | 166 as of facelift (code 806), saddle brown leather (equipment code 224A) |

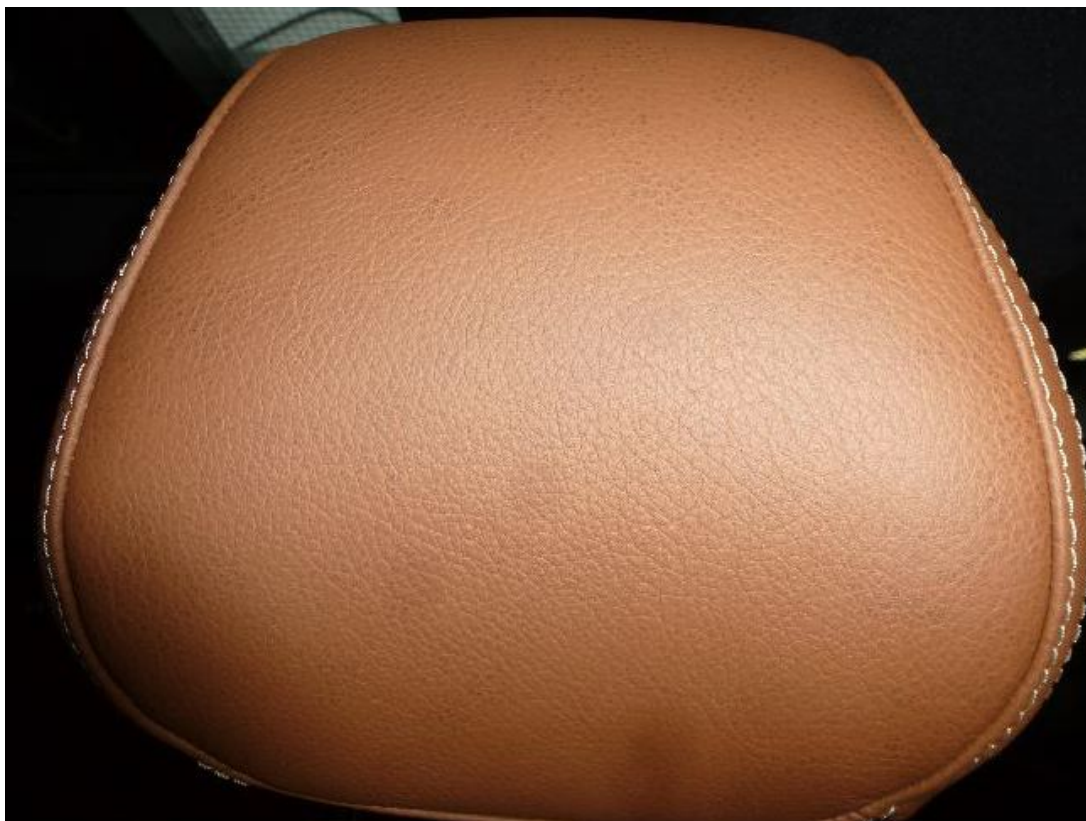
wolkendesign-1.JPG:

Blackish stains on the leather surfaces with equipment code 224A (see photos in attachment).

| Attachments | |
|---|---|
| wolkendesign-1.JPG | Cloud design on head restraint |

In isolated cases, the cloud print on the surface of the leather may be too pronounced, which a customer may describe as slight "soiling"

- Do not replace any seat covers or head restraints at the present time, because the customer may have a similar complaint about the cloud print on the replacement part.

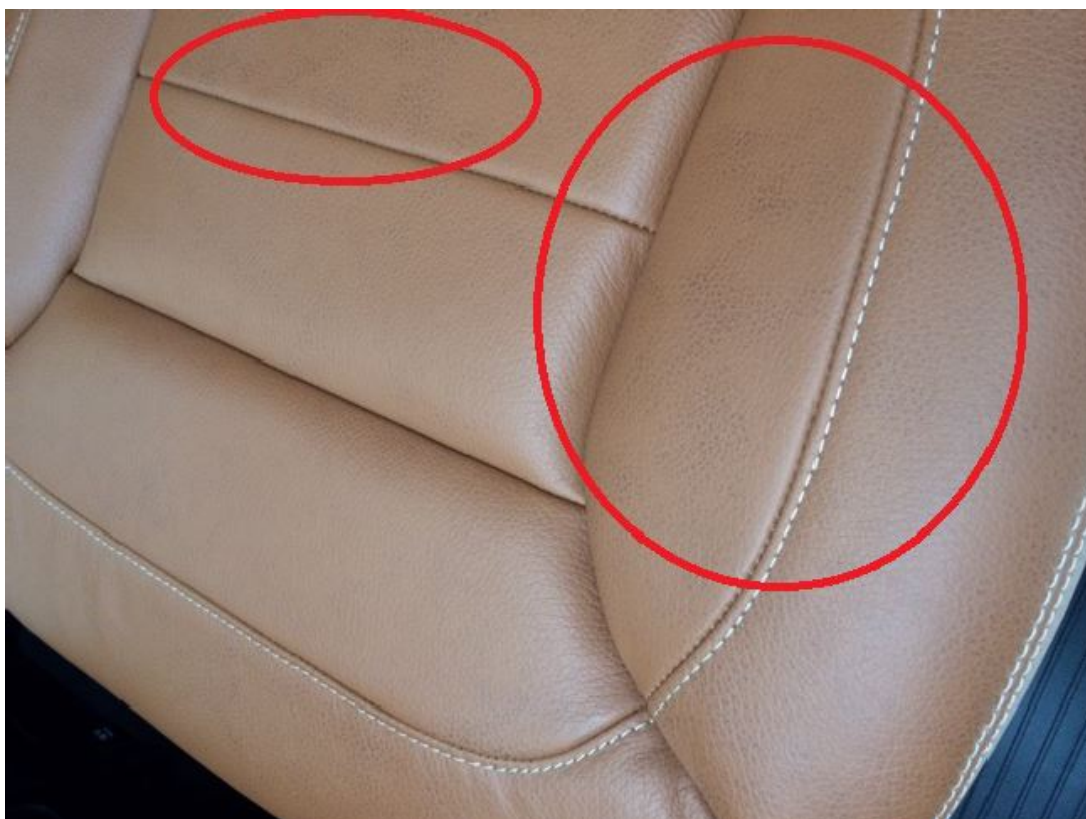
wolkendesign-2.JPG:

| Attachments | |
|---|---|
| wolkendesign-2.JPG | Cloud design on seat surface |
