TO: Mercedes-Benz Dealer Principals, General Managers, Sales Managers, Service Managers, Parts Managers	FROM: Thomas Brunner, Department Manager, Vehicle Compliance and Analysis, Engineering Services
RE: Service Campaign 2016030010 Model 205 C-Class (AMG), MY 2015 – 2016 Retrofit Two Stop Plugs at Right Spare Wheel Well	DATE: April 22, 2016

Campaign No. 2016030010, April 2016

SUBJECT: **Model 205 (AMG), Model Years 2015 - 2016**
Retrofit Two Stop Plugs at Right Spare Wheel Well

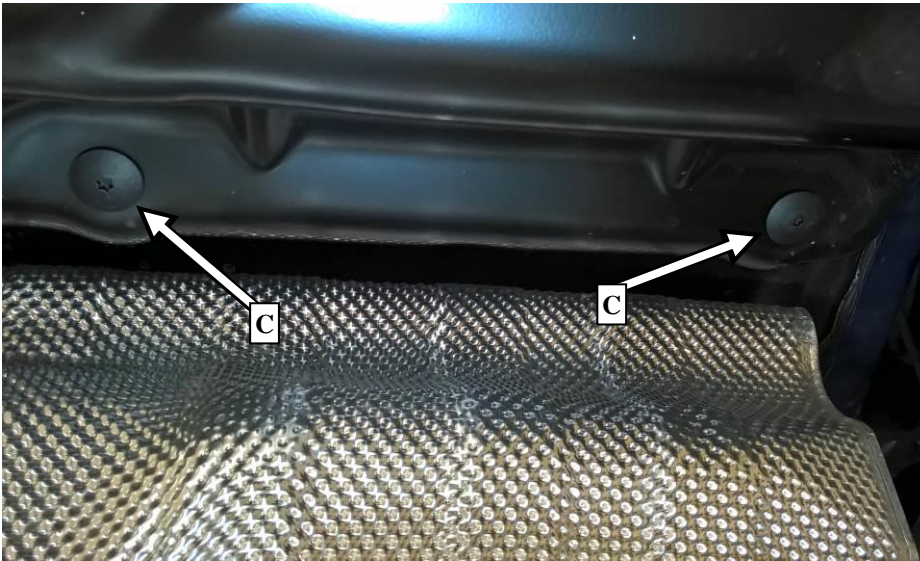
Figure 3

This Service Campaign has been initiated because Daimler AG (DAG), the manufacturer of Mercedes-Benz vehicles, has determined that the stop plugs at the spare wheel well may not have been installed according to specification. It is therefore possible that water entry may occur in the area of the spare wheel well. An authorized Mercedes-Benz dealer will retrofit the stop plugs at the spare wheel well.

Install two missing stop plugs (C, Figure 3) at spare wheel well then reassemble in reverse order.
