# Service Campaign Bulletin

Campaign No. 2016020012, April 2016

SUBJECT: **Model 117, Model Year 2014**  
**Rework Seam Seal at Right Tail Lamp**

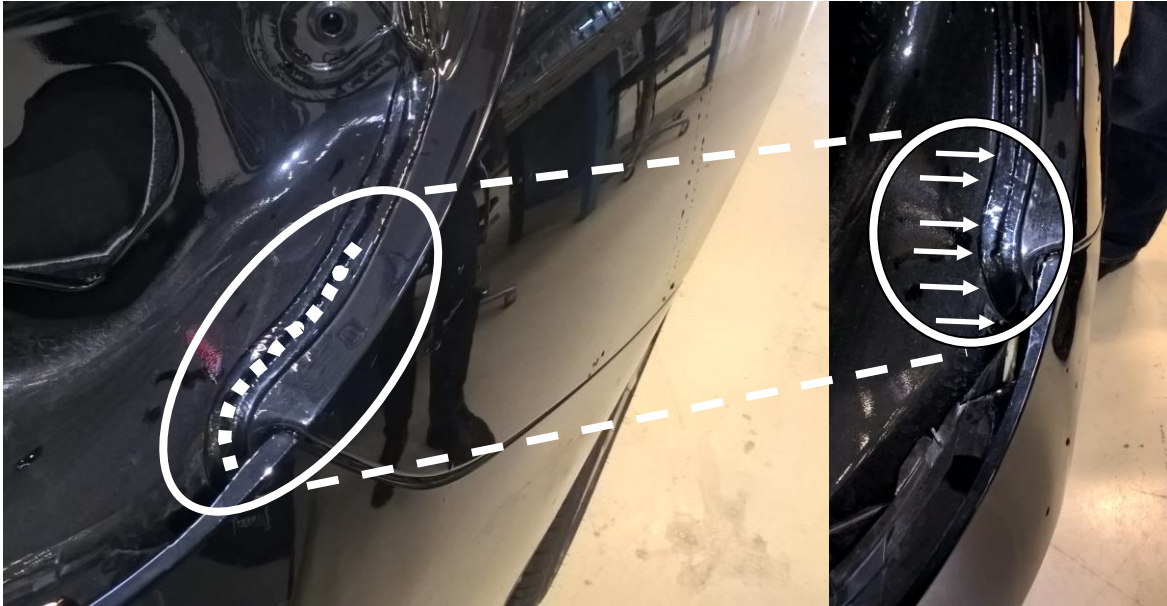
**Figure 1**

This Service Campaign has been initiated because Daimler AG (DAG), the manufacturer of Mercedes-Benz vehicles, has determined that it is possible that a seal seam at the right tail lamp was applied not meeting our specifications. To remedy this, an authorized Mercedes-Benz dealer will correct the seal seam at the right tail lamp.

1. Remove right tail lamp.
2. Thoroughly clean seam seal in marked area (Figure 1) and then degrease with silicone remover (shop supply).
3. Apply and spread sealant in marked area (Figure 1).
