NUMBER: 08-067-16

Ignition Node Module Replacement

2016	(DS)	Ram 1500 Pickup
2016	(DJ)	Ram 2500 Pickup
2016	(D2)	Ram 3500 Pickup
2016	(DP)	Ram 4500/5500 Cab Chassis

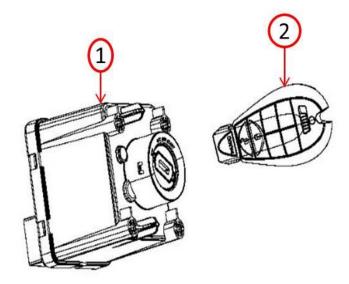
Fig. 1 Ignition Node Module

Some customers may experience a no start issue when turning the key fob in the ignition node module(Fig. 1).

1. Replace the ignition node module. Refer to the detailed service procedures available in DealerCONNECT> TechCONNECT under: Service Info>08 - Electrical/8E - Electronic Control Modules/Module, Ignition Node/Removal/Installation.
