Program Bulletin

CUSTOMER SATISFACTION PROGRAM

SUBJECT: Oil Pickup Tube Bolt Retention

MODELS: 2016 Cadillac CTS-V Equipped with 6.2L V-8 (RPO LT4)
2016 Chevrolet Camaro SS Equipped with 6.2L V-8 (RPO LT1)

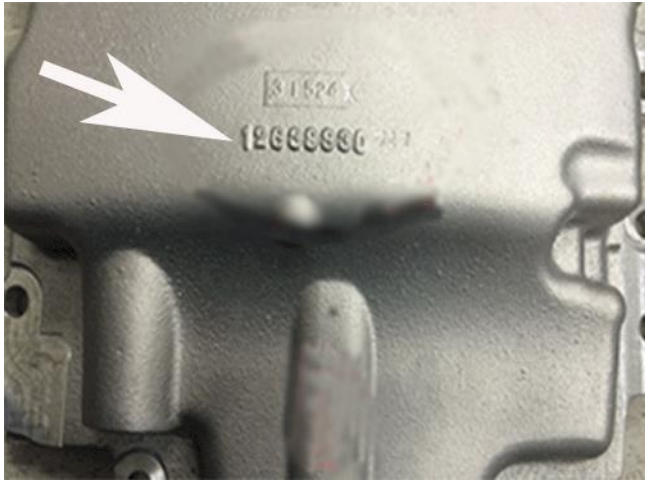
4484708

Use the following steps to inspect the identification number on the front of the oil pan. All oil pans will have markings in this area, some are engraved and some are raised. Only vehicles with the raised cast in numbers require repair. If the oil pan has the raised casting numbers, it will be necessary to service or replace the oil pan.

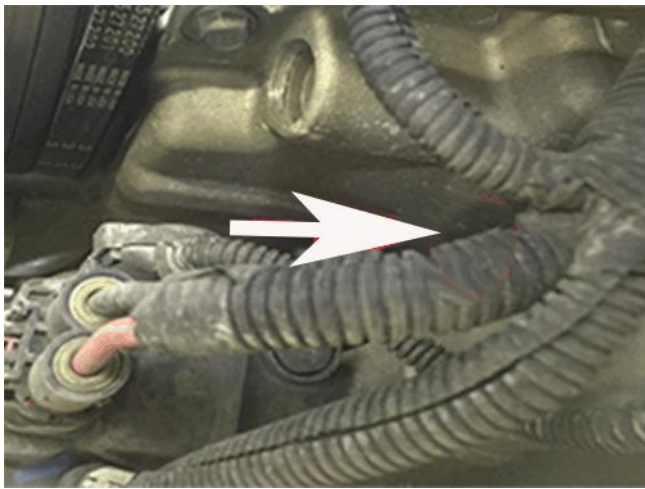
4484710

2. Using a flashlight and a mirror, inspect the identification markings on the front area of the oil pan. It may be necessary to move the wiring harness to see the number.
 - If the pan has raised marking in this location the pan will need to be repaired or replaced. Proceed to the repair procedure.
 - If the raised markings are not present no further action is required.

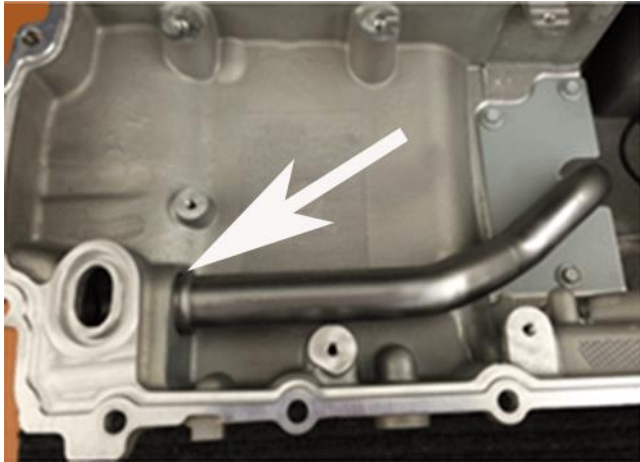
4484705

3. Inspect the oil pick up tube where it joins the oil pan assembly.

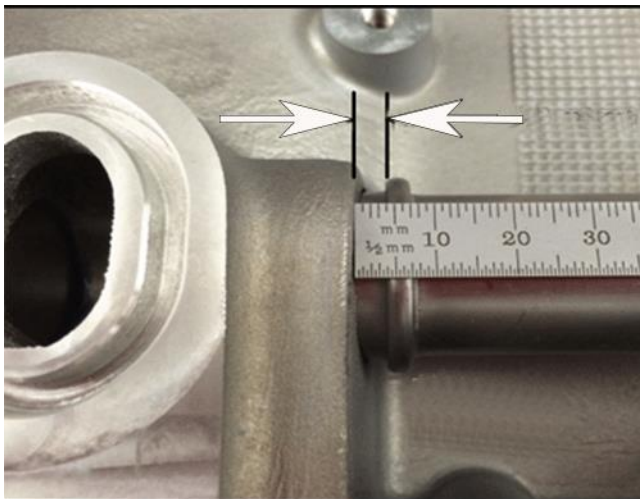
4484703

- If the bead on the pickup tube is **less than** 5.0 mm (13/64) from the oil pan port, proceed to the OIL PAN BOLT REPLACEMENT section below.
- If the bead on the pickup tube is **more than** 5.0 mm (13/64) from the oil pan port, replace the oil pan assembly. Refer to *Oil Pan Replacement* in SI.
