# Program Bulletin

## CUSTOMER SATISFACTION PROGRAM

**SUBJECT:** Rear Trailing Arm Bolt Grease

**MODELS:** 2016 Chevrolet Malibu

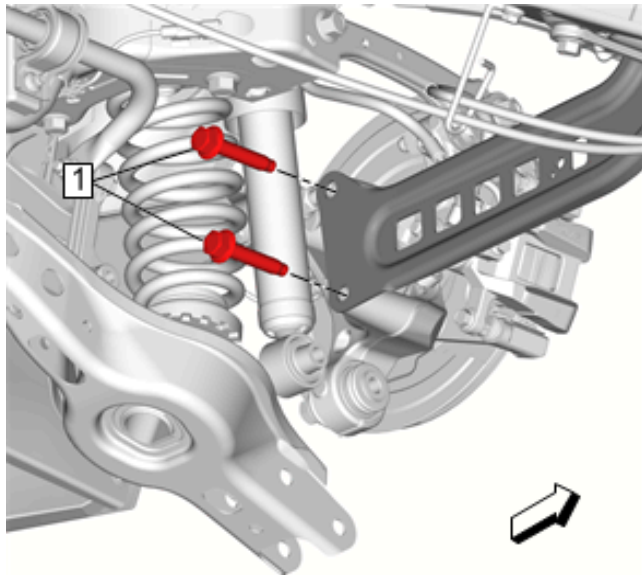
4196192

**Note:** The control arm to shock bolt is pictured as being removed below for illustrative purposes **ONLY**. Do not remove the control arm to shock absorber bolt.

6. Remove the two left trailing arm to knuckle bolts (1). Discard the bolts.
