Service Bulletin

SUBJECT: Service Update for Inventory Vehicles Only
Transmission to Engine Bolt Torque
Expires April 30, 2017

MODELS: 2016 Chevrolet Silverado
2016 GMC Sierra

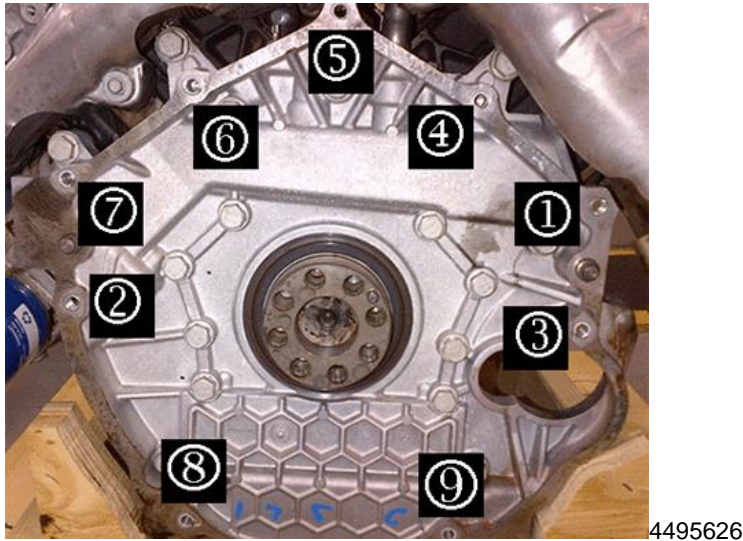
Illustration depicts a diesel engine. The gasoline engine does not have a bolt at position 4.

8. Loosen the transmission bolts in the sequence shown.

Note: Position 4 does not apply to gasoline engine.

9. Tighten the transmission bolts 1 and 2 to 50 Nm (37 lb. ft.). Starting with position 1 again, tighten bolts in sequence 1-9 as shown to 50 Nm (37 lb. ft.).
10. Install the fuel line bracket nut on the back of the transmission at the engine and reposition the fuel line bracket.
11. Raise the transmission back into place.
12. Install the three-way catalytic converter. Refer to *Three-Way Catalytic Converter Replacement* in SI.
13. Install the front axle propeller shaft, if equipped. Refer to *Front Axle Propeller Shaft Replacement* in SI.
14. Install the transmission support crossmember. Refer to *Transmission Support Crossmember Replacement* in SI.
15. Install the rear propeller shaft. Refer to *Rear Propeller Shaft Replacement* in SI.
16. Lower the vehicle. Refer to *Lifting and Jacking the Vehicle* in SI.

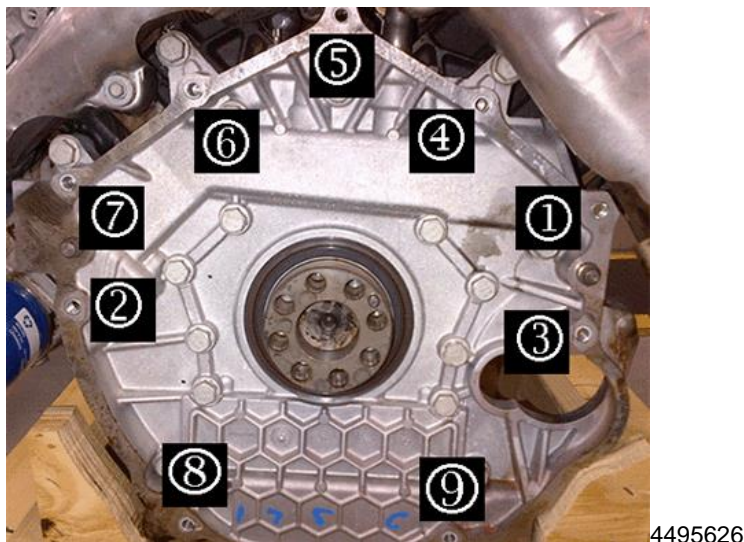
Illustration depicts a diesel engine. The gasoline engine does not have a bolt at position 4.

5. Loosen the transmission bolts in the sequence shown.

Note: Position 4 does not apply to gasoline engine.

- 6. Tighten the transmission bolts 1 and 2 to 50 Nm (37 lb. ft.). Starting with position 1 again, tighten bolts in sequence 1-9 as shown to 50 Nm (37 lb. ft.).
- 7. Reposition the wire harness/vent tube bracket and install the wire harness/vent tube bracket nut.
- 8. Raise the transmission back into place.
- 9. Install the transmission support crossmember. Refer to *Transmission Support Crossmember Replacement* in SI.
- 10. Lower the vehicle. Refer to *Lifting and Jacking the Vehicle* in SI.
