Service Bulletin

Subject: Delayed Engagement After Sitting With Engine Off - Torque Converter Fluid Drain Back

Not Wanting to Move or Slips - Torque Converter Drain Back

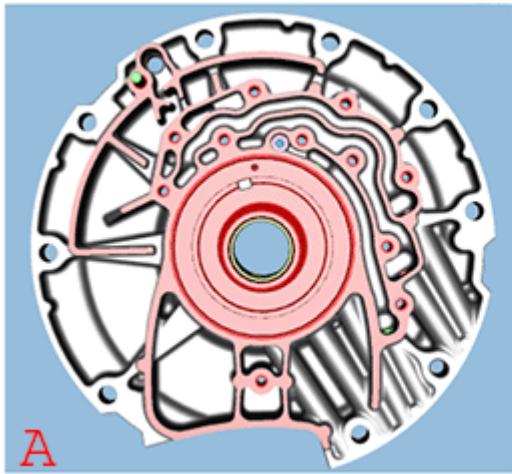
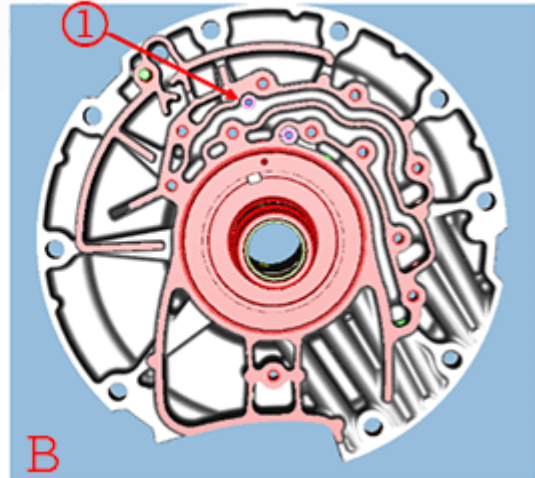
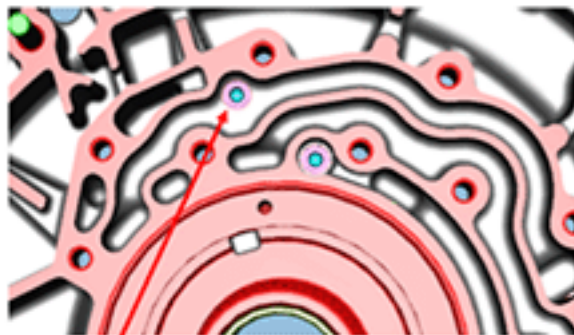
- A. Old stator support asm
- B. New stator support asm

Note: The new stator shaft support assembly has a second check ball (1) added (see illustrations).

Install a new stator shaft support assembly that includes an additional check ball. Follow the instructions below to replace the stator shaft support assembly.
