Service Bulletin

Subject: Shake and/or Shudder During Light Throttle Acceleration Between 48 and 104 KM/H (30 and 65 MPH) at a Steady State

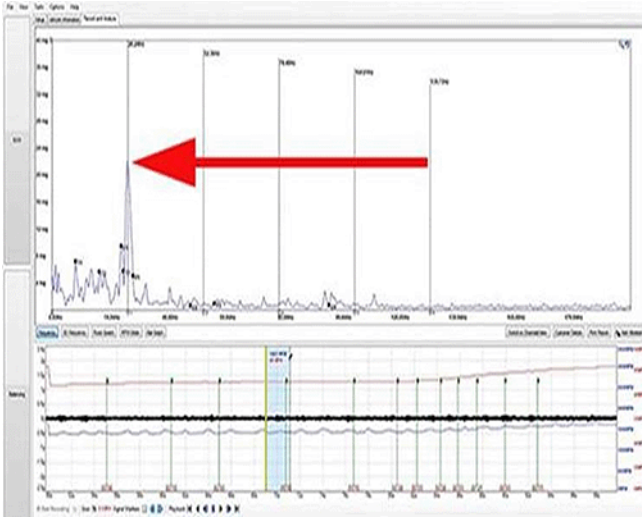
The disturbance will display as unknown and will be around 26 Hz at 16 to 24 mg as shown in the illustration above if the concern is TCC shudder.

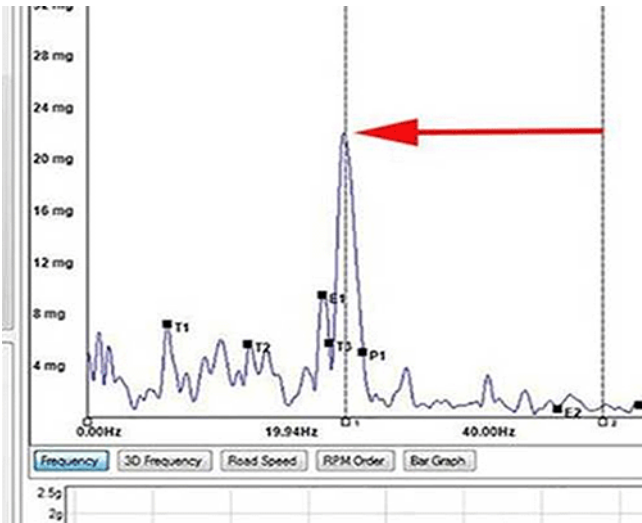
In the above illustration frequency and default view have been selected.
