# Service Bulletin

**Subject:** Fuel Odor, Fuel Smell, Fuel Leak, Fuel Weeping from Top of Tank, DTC P0442 May Be Set

| Brand: | Model: | Model Year: | | VIN: | | Engine: | Transmission: |
|---|---|---|---|---|---|---|---|
| Chevrolet | Colorado | 2015 | 2017 | | | All | All |
| GMC | Canyon | 2015 | 2017 | | | | |

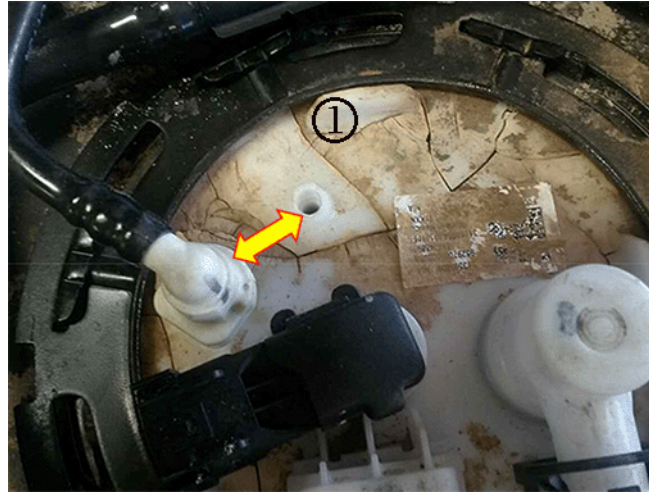
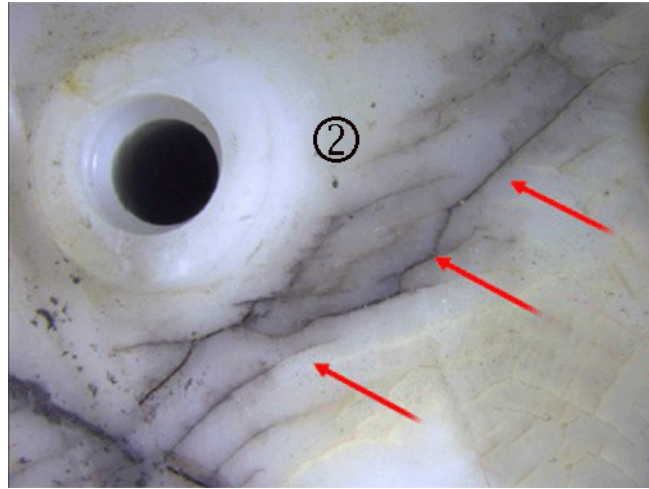
The cause may be sulfuric acid, or other such chemicals, placed in the bed of the truck that has either leaked or been washed through the holes in pickup box, and settled onto the top of the fuel tank. Examples of chemical damage to the fuel pump module such as a fractured port (1) and cracks in the plastic flange (2), are shown in the graphics above.

Verify fuel pump damage/failure and follow the Service Procedure below to replace the fuel pump and seal the pickup box.

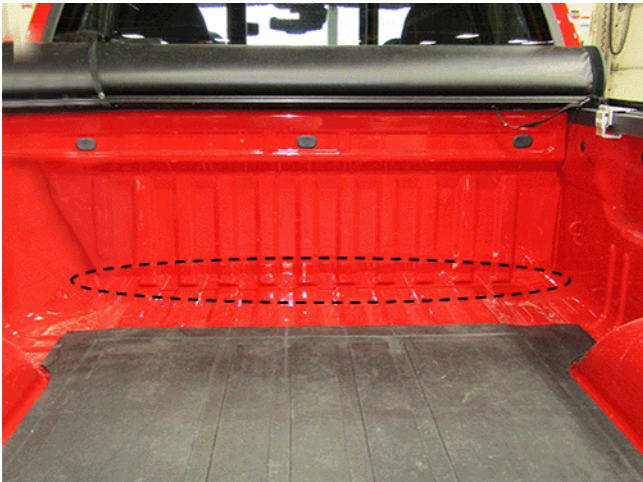
The top side front joint of the pickup bed floor and front panel, shown circled above, is the area that seam sealant will be applied.
