Service Bulletin

Subject: Water Leak Around Rear Window, Water Found in Trunk, Possible Malfunction Indicator Lamp (MIL) Illuminated

Brand:	Model:	Model Year:		Date Breakpoint:		Engine:	Transmission:
		from	to	from	to		
Chevrolet	Cruze (VIN B)	2016	2016			All	All
Chevrolet	Cruze (VIN B) Notchback	2017	2017	SOP 2017	September 6, 2016

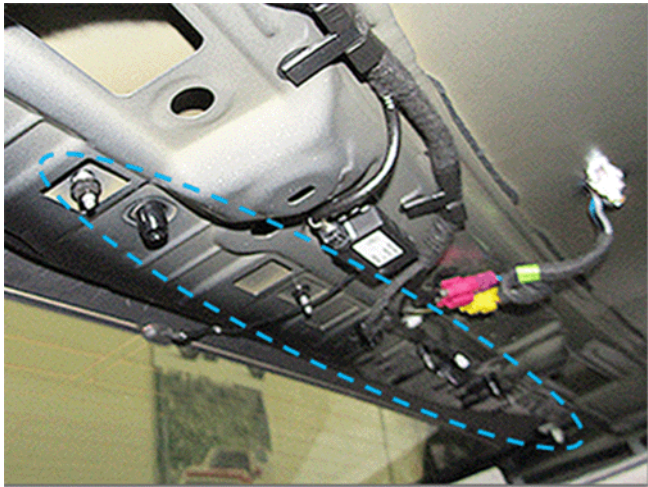
<p>The cause of the condition may be loose or missing nuts retaining the Center High Mounted Stop Lamp (CHMSL), which may allow water to by-pass the CHMSL and flow into the trunk area.</p>

2. If water is found in the battery well area, remove both floor drain plugs from the bottom of the well to allow water to drain out.
3. Lower the rear of the headliner enough to access the four nuts that retain the CHMSL. Refer to the appropriate *Headlining Trim Panel Replacement* procedure, in SI.

4. Remove the **right side, inboard** nut from the CHMSL.
5. Apply LOCTITE® Threadlocker Blue 242 ®, (P/N 9985283; in Canada 10953489), to the stud.
6. Finger start the nut onto the stud.
Tighten: Tighten the nut to 8 Y (70 lb in).

7. Continue to remove, apply LOCTITE® and re-tighten remaining nuts **in this sequence:**
 - 7.1. Left side, inboard
 - 7.2. Left side, outboard
 - 7.3. Right side, outboard
