Service Bulletin

Subject: Sunroof Rattle, Creak, Tick and/or Double Click Noise During Operation

Brand:	Model:	Model Year:		VIN:		Engine:	Transmission:
		from	to	from	to		
Cadillac	CT6	2016	2017			All	All

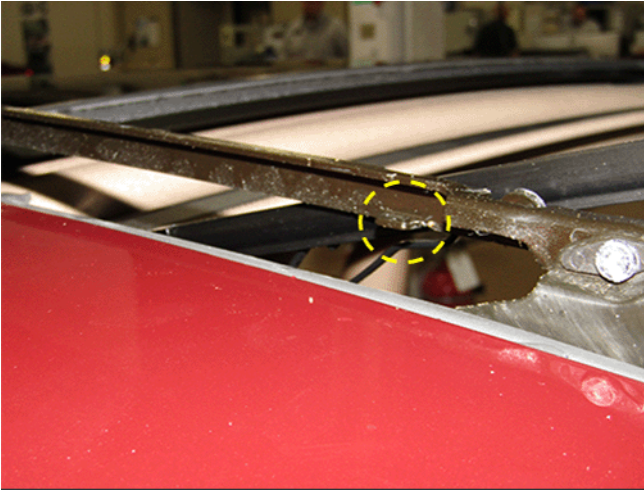
Note: The right side tab is shown circled in the graphic above. The front sunroof window was removed for illustration purposes only.

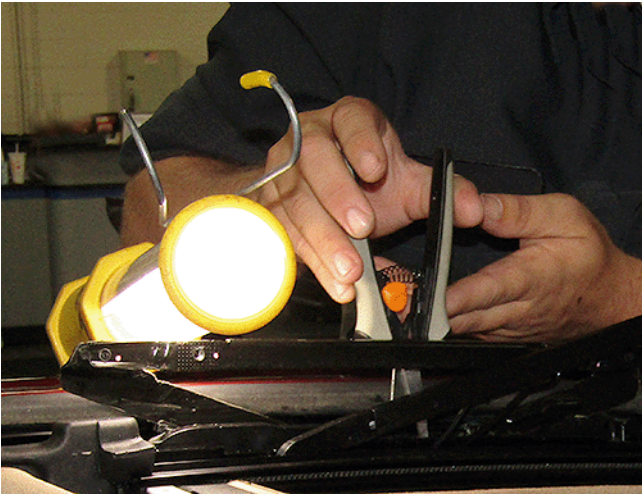
3. Locate the small "tail" extrusion on the rubber isolator on one side of the sunroof.

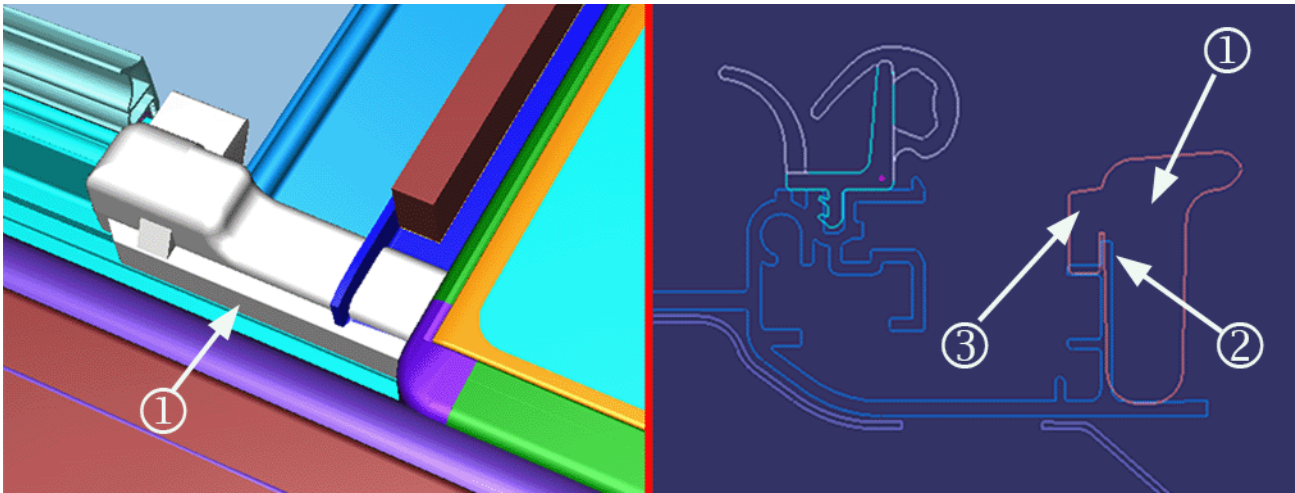
Note: To improve performance, a more robust second design of the sunroof inner middle seal has been implemented. The first graphic above shows the difference between the first (1) and second (2) design level.

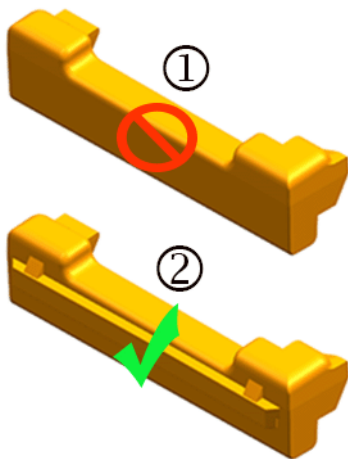
Note: The second graphic shows an illustration and cross-section of the correct positioning of the second design seal (1). The added portion of the seal (3) is intended to cap-over the guide flange (2) and isolate the drain channel from contact with the guide flange.

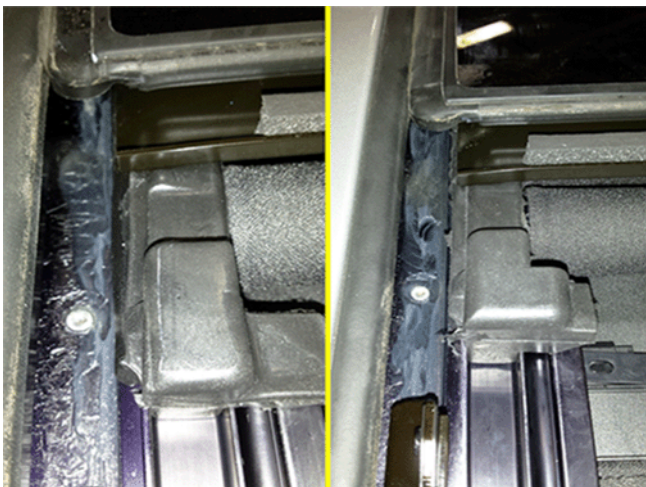
- ⇒ Inspect the seals for evidence of them being mis-positioned, or rolled out of position on either or both sides. If this condition exists and the guide flange is exposed, there will likely be corrosion evident (shown circled above), due to the metal to metal contact of drain channel to the guide. If exposure of the guide flange or corrosion is evident, continue to step #12.

12. For vehicles with first design seals, replace both sides; for second design seals, replace only the affected side. Refer to *Sunroof Window Seal Replacement (Inner Middle Seal With C3U)* in SI.
13. Reinstall the sunroof housing assembly. Refer to *Sunroof Housing Replacement (With C3U)* in SI.
14. Move ahead to step #17.

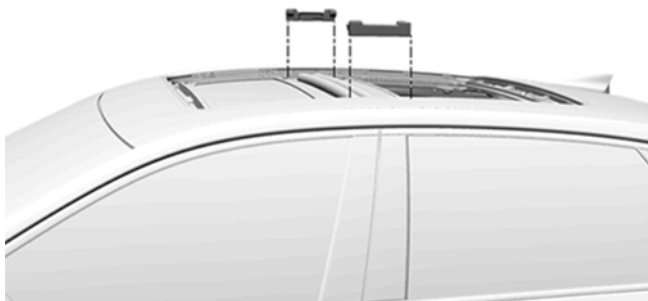
- ⇒ The graphic above shows examples of proper seal installation. Some slight roll of the seal is acceptable as long as the drain channel is completely isolated from the guide flange. If they are properly positioned on both sides, move ahead to step #13.

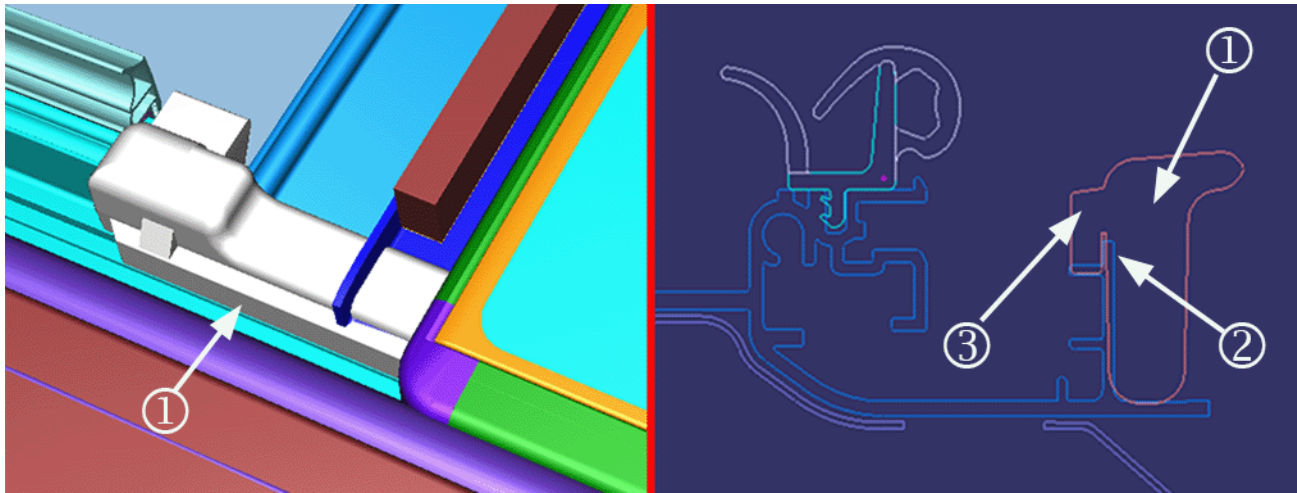
Note: To improve performance, a more robust second design of the sunroof inner middle seal has been implemented. The first graphic above shows the difference between the first (1) and second (2) design level.

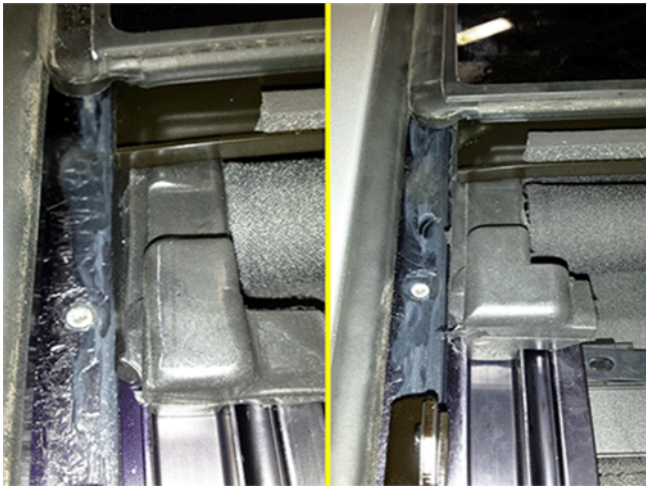
- ⇒ Inspect the seals for evidence of them being mis-positioned, or rolled out of position on either or both sides. If this condition exists and the guide flange is exposed, there will likely be corrosion evident (shown circled above), due to the metal to metal contact of drain channel to the guide. If exposure of the guide flange or corrosion is evident, continue to step #16.

16. For vehicles with first design seals, replace both sides; for second design seals, replace only the affected side. Refer to *Sunroof Window Seal Replacement (Inner Middle Seal With C3U)* in SI.
17. Verify noise conditions have been eliminated and proper operation of sunroof.

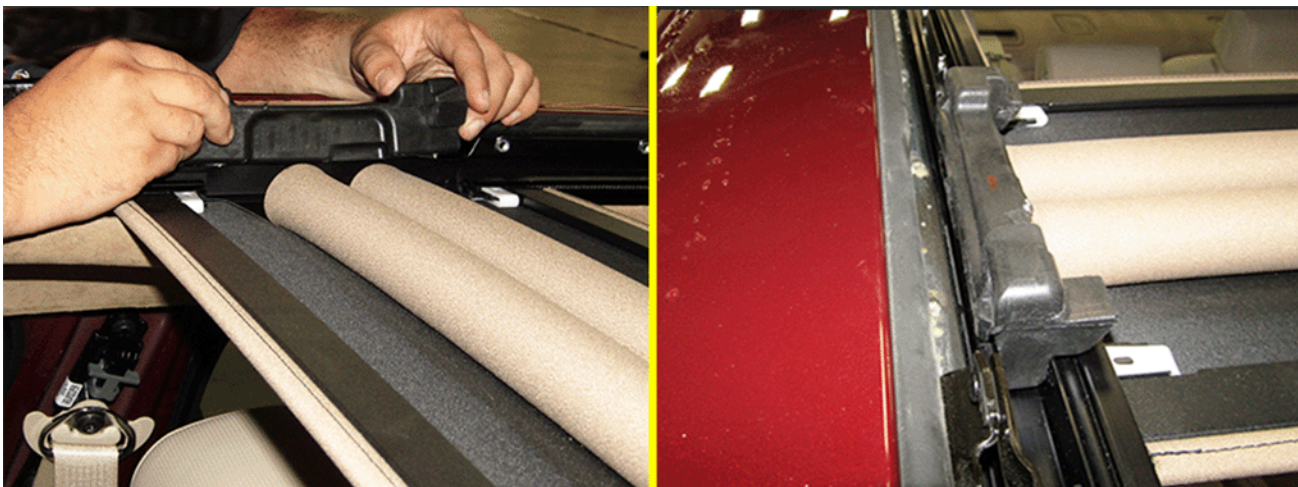
- ⇒ The graphic above shows examples of proper seal installation. Some slight roll of the seal is acceptable as long as the drain channel is completely isolated from the guide flange. If they are properly positioned on both sides, move ahead to step #17.
