Bulletin No.: 16-NA-378

Service Bulletin

Subject: Intermittent IPC Gauges Drop Out, Passenger Airbag Indicator "OFF"/Radio/HVAC Displays Blank Out, Airbag Readiness Light On, Service Airbag/Service Theft Deterrent/Service Tire Pressure Monitor Messages Displayed, No Crank No Start - DTCs U0073, U0078, U0140, U0151, U0155, U0164, U0184 Set

Brand:	Model:	Model Year:		Vehicle Build Date:		Engine:	Transmission:
		from	to	from	to		
Chevrolet	Malibu	2013	2014	SOP	March 14, 2014

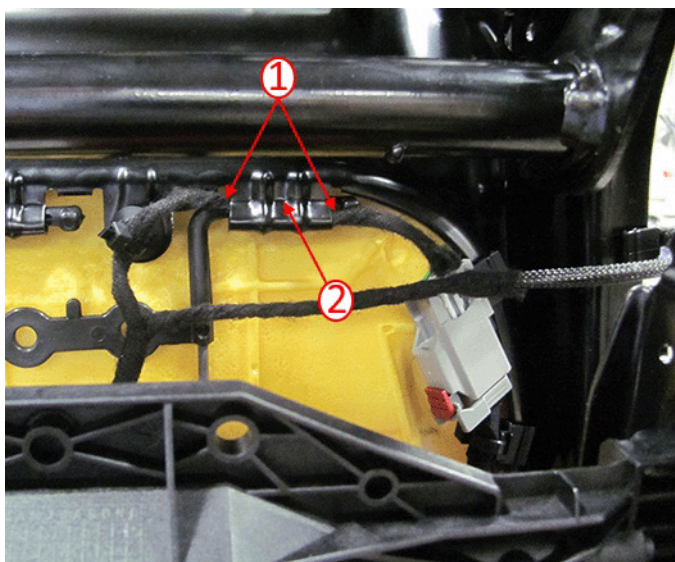
Condition	<p>Some customers may comment on any of the following conditions:</p> <ul style="list-style-type: none"> • Service Airbag message displayed. • Airbag Readiness light on. • IPC/Cluster gauges drop to the rest position. • Radio display blanks out. • HVAC display blanks out. • Passenger airbag indicator “OFF” with passenger seat occupied. • Service theft deterrent message displayed. • Service tire pressure monitor message displayed. • No crank/no start. <p>The Technician may find:</p> <ul style="list-style-type: none"> • Air bag fuse blown. • DTC Set: <ul style="list-style-type: none"> – U0073 – U0078 – U0140 – U0151 – U0155 – U0164 – U0184
Cause	<p>This condition may be caused by the wiring harness chaffing against the seat frame or a short to ground in the 5060 circuit.</p>

If the condition has been duplicated, inspect the passenger side seat wiring harness for possible damage (1) and/or improper routing through the seat frame (2).

If the harness has been found to be the cause of the concern, proceed with the following procedure.

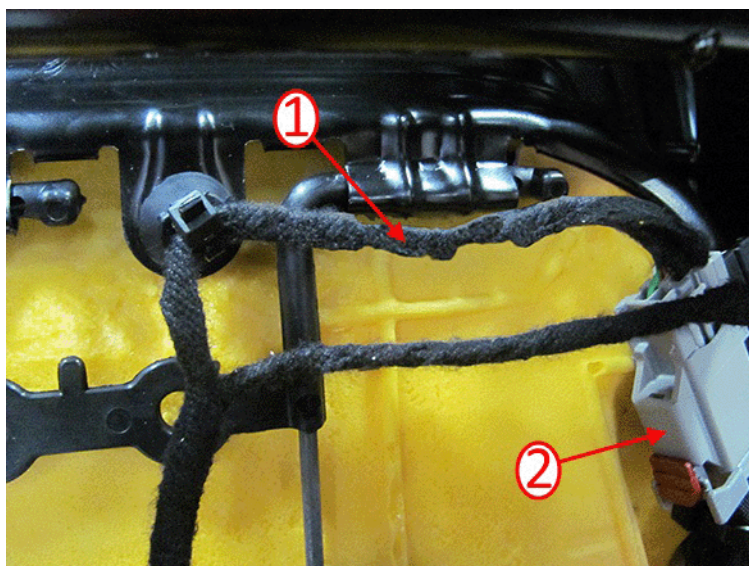
Note: If there is no chaffing or exposed bare copper wire, continue with diagnosis referring to SI.

1. Remove the passenger seat. Refer to *Driver or Passenger Seat Removal and Installation* in SI.
 - If the wiring harness has been found to be routed through the seat frame, re-route the harness away from the frame as shown above.
 - If necessary, disconnect the electrical connector (2).
2. Inspect the passenger seat wiring harness for chaffing or exposed copper wire (1).
3. Repair exposed and/or separated wiring. Refer to *Repairing Damaged Wire Insulation* in SI.
