Service Bulletin

Subject: Head Restraint Material Coming Loose

Brand:	Model:	Model Year:		VIN:		Engine:	Transmission:
		from	to	from	to		
Buick	LaCrosse	2015	2016	SOP	September 9, 2016	All	All
Cadillac	XTS	2015	2017	SOP	September 9, 2016	All	All
Chevrolet	Impala (VIN 1)	2015	2017	SOP	September 9, 2016	All	All

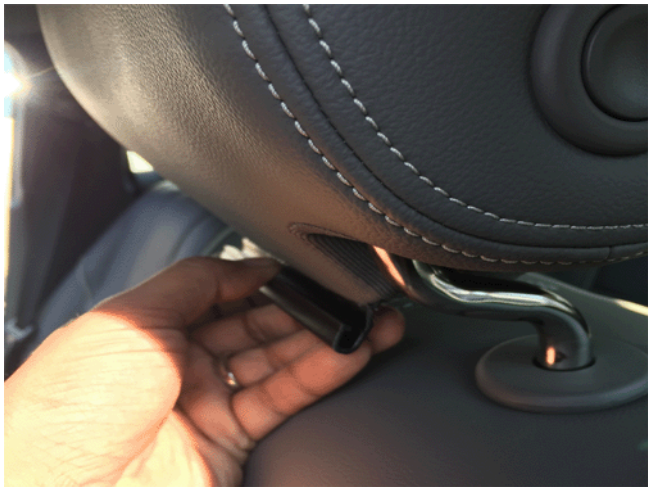
<p>Some customers may comment that the material from the headrests is coming loose.</p>
Cause	This may be due to the J-clips not being robust enough to hold the material in place.
