Service Bulletin

Subject: Loss of Driver and/or Passenger Front HVAC Floor Duct Airflow, Popping Noise from Instrument Panel (IP) Area

Brand:	Model:	Model Year:		Date Breakpoint:		Engine:	Transmission:
		from	to	from	to		
Cadillac	CT6 (Plant Location U: 11th Position of VIN)	2016	2017	SOP 2016	September 30, 2016	All	All

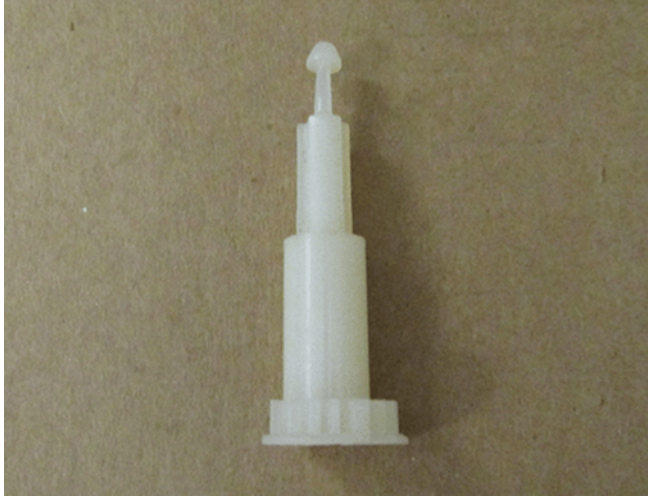
<p>The cause of the condition may be floor door gears in the front HVAC module may have been loosely installed by the supplier, with the retention features not fully engaged. This may cause the gear(s) to become unseated and potentially back out/fall out of the HVAC module.</p>

Verify the condition and inspect/re-engage the front HVAC floor door gears on BOTH the driver and passenger side following the Service Procedure below.
